OIL ANALYSIS REPORT

AMERICAN COUNTESS [AMERICAN COUNTESS] AMERICAN COUNTESS - Z DRIVE SB Component

Starboard Gearbox

MOBIL MOBILGEAR 600 XP ISO 150 (--- GAL)

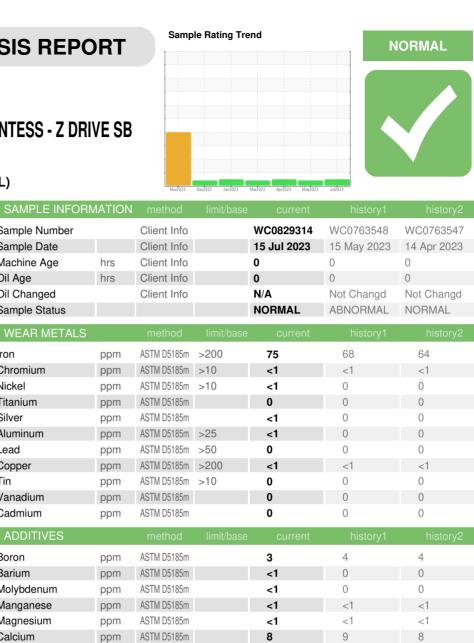
All component wear rates are normal.

There is no indication of any contamination in the oil

The AN level is acceptable for this fluid. The condition of the oil is suitable for further service.

Resample at the next service interval to monitor. NOTE: Please provide information regarding reservoir capacity, filter type and micron rating with next sample. Please specify the component make and model with your next sample.
