# OIL ANALYSIS REPORT

Machine Id  
**TE6 (S/N 19P2821)**

Component  
**Agitator Gearbox**  
Fluid  
**NOT GIVEN (--- GAL)**

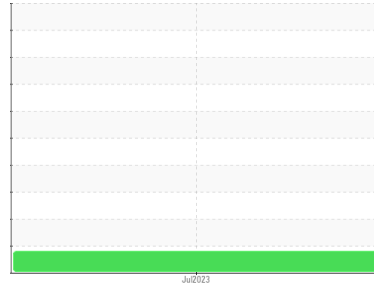
Sample Rating Trend

**SEDIMENT**

There is a high amount of visible silt present in the sample.

Resample at the next service interval to monitor.

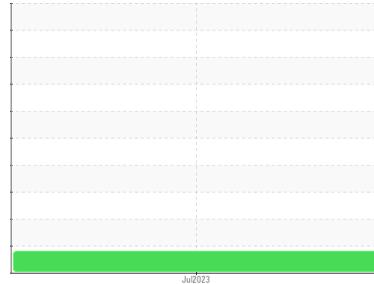
Sample Rating Trend

SEDIMENT

Resample at the next service interval to monitor.

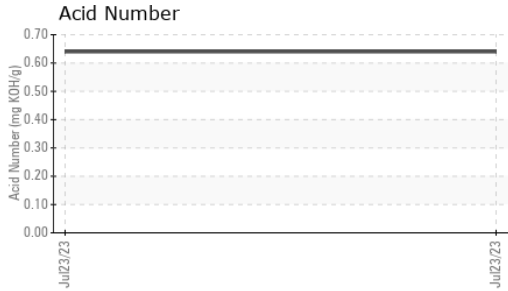
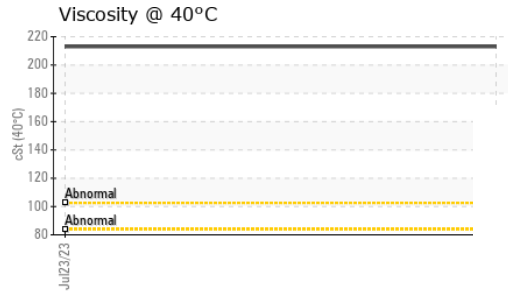
Sample Status				<b>ABNORMAL</b>	---	---
Silt	scalar	*Visual	NONE	<b>▲ HEAVY</b>	---	---

The AN level is acceptable for this fluid. The condition of the oil is acceptable for the time in service.

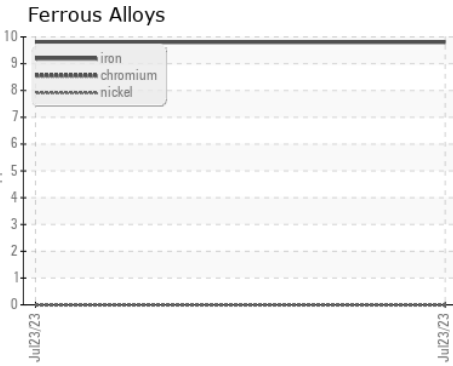
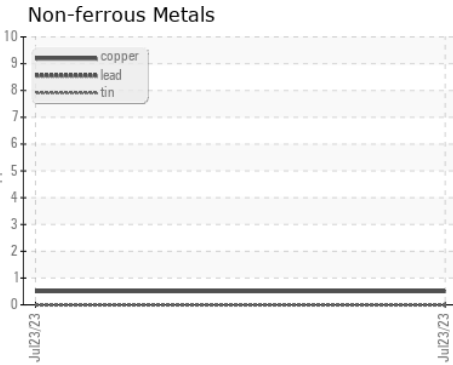
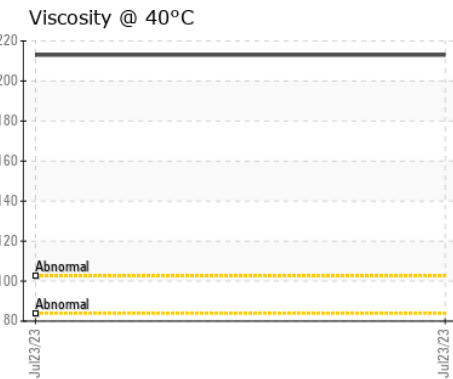
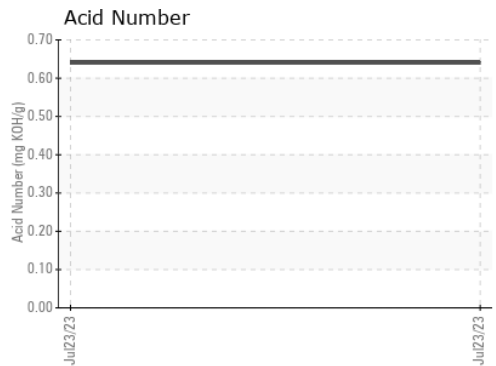
## GRAPHS

All component wear rates are normal.
