# OIL ANALYSIS REPORT

**G54**

**Transmission (Auto)**

**CASTROL TRANSYND 668 (--- GAL)**

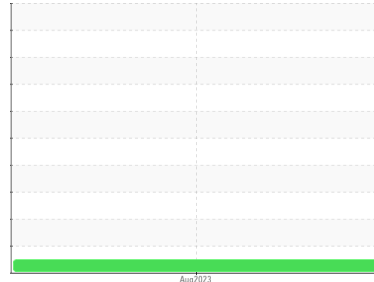
Sample Rating Trend

**NORMAL**

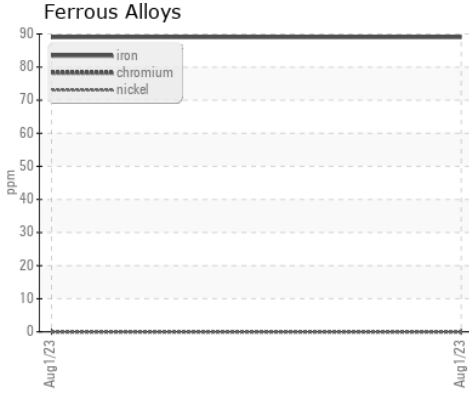
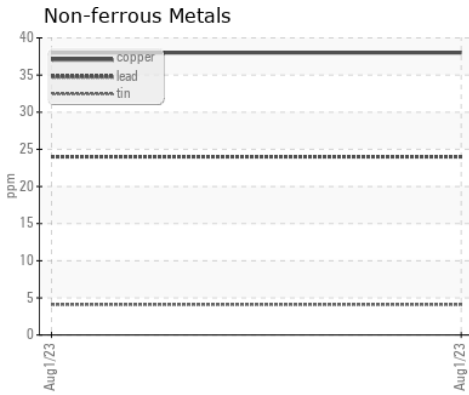
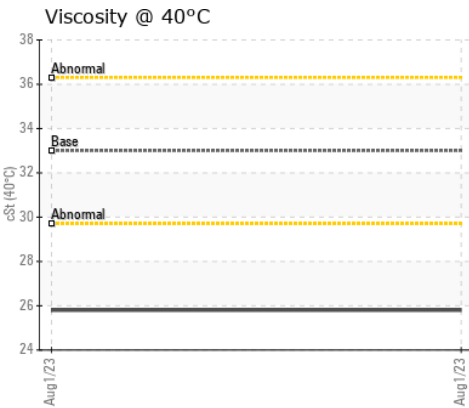
## GRAPHS

All component wear rates are normal.

There is no indication of any contamination in the fluid.

The condition of the fluid is acceptable for the time in service.

Resample at the next service interval to monitor.
