Area
HERTZ SMART OIL
 Machine Id
HERTZ VD016729 - ADASEAL
 Component
Compressor
 Fluid
SMARTOIL 6000 (--- GAL)

OIL ANALYSIS REPORT

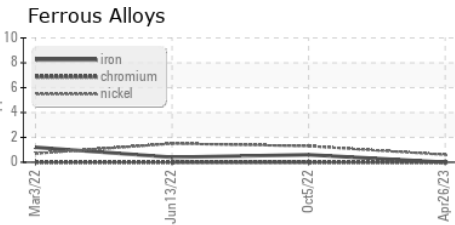
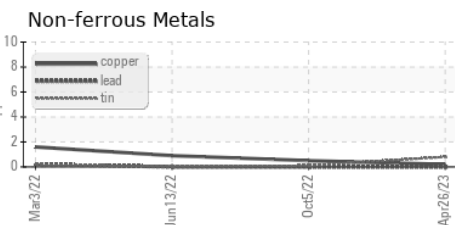
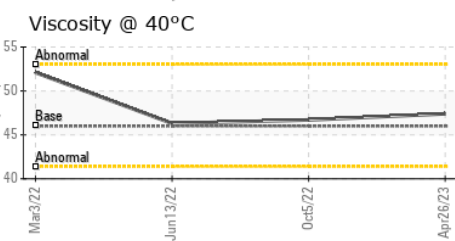
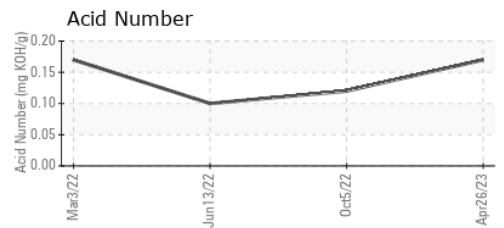
GRAPHS

Wear
 All component wear rates are normal.

Contamination
 There is no indication of any contamination in the oil.

Fluid Condition
 The AN level is acceptable for this fluid. The condition of the oil is suitable for further service.

Recommendation
 Resample at the next service interval to monitor.
