# PROBLEM SUMMARY

Machine Id  
**JOHN DEERE 333G 1T0333GMVLF369749**  
 Component  
**Diesel Fuel**  
 Fluid  
**NOT GIVEN (--- GAL)**

# FUEL REPORT

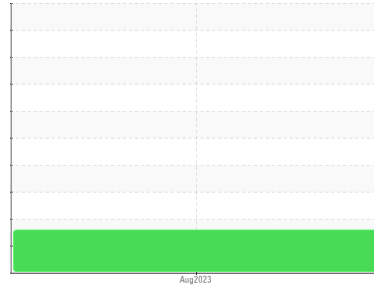
Sample Rating Trend

**WATER**

Free water present.

This is a baseline read-out on the submitted sample. We advise that you follow the water drain-off procedure for this component.

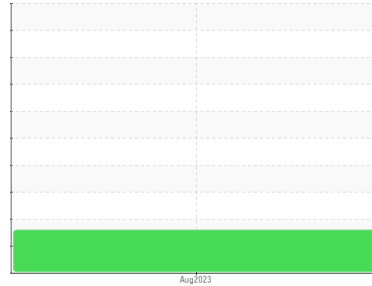
Sample Rating Trend

**WATER**

All metal levels are normal indicating no corrosion in the system.

The condition of the fuel is acceptable for the time in service.

This is a baseline read-out on the submitted sample. We advise that you follow the water drain-off procedure for this component.
