**Customer Id:** JVOLIN  
**Sample No.:** KCPA005643  
**Lab Number:** 05925470  
**Test Package:** IND 2

# OIL ANALYSIS REPORT

Machine Id  
**KAESER SK 15 5971986 (S/N 1199)**  
 Component  
**Compressor**  
 Fluid  
**KAESER SIGMA (OEM) S-460 (--- QTS)**

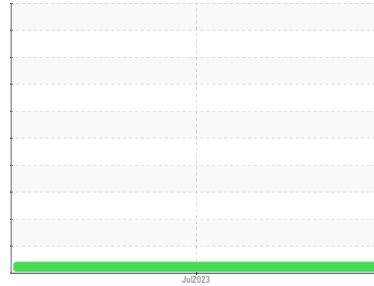
Sample Rating Trend

Sample Status				<b>ABNORMAL</b>	---	---
Debris	scalar	*Visual	NONE	<b>▲ MODER</b>	---	---

The filter change at the time of sampling has been noted. Resample at the next service interval to monitor. We were unable to perform a particle count due to a high concentration of particles present in this sample.

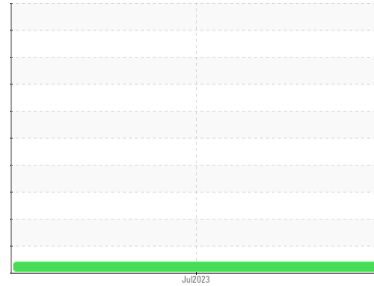
Sample Rating Trend

Moderate concentration of visible dirt/debris present in the oil.

The filter change at the time of sampling has been noted. Resample at the next service interval to monitor. We were unable to perform a particle count due to a high concentration of particles present in this sample.

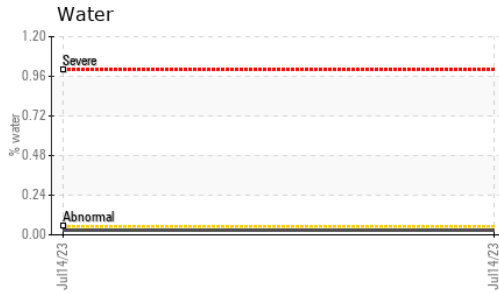
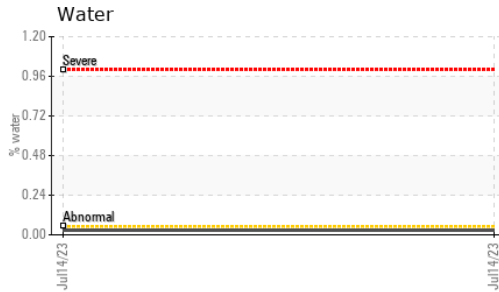
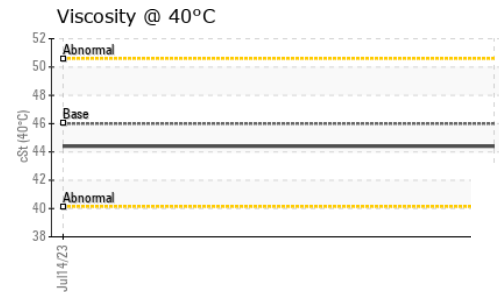
VISUAL	method	limit/base	current	history1	history2
White Metal	scalar	*Visual	NONE	<b>NONE</b>	---
Yellow Metal	scalar	*Visual	NONE	<b>NONE</b>	---
Precipitate	scalar	*Visual	NONE	<b>NONE</b>	---
Silt	scalar	*Visual	NONE	<b>NONE</b>	---
Debris	scalar	*Visual	NONE	<b>▲ MODER</b>	---
Sand/Dirt	scalar	*Visual	NONE	<b>NONE</b>	---
Appearance	scalar	*Visual	NORML	<b>NORML</b>	---
Odor	scalar	*Visual	NORML	<b>NORML</b>	---
Emulsified Water	scalar	*Visual	>0.05	<b>NEG</b>	---
Free Water	scalar	*Visual		<b>NEG</b>	---
