Machine Id  
**KAESER 8118689**

Component  
**Compressor**

Fluid  
**KAESER SIGMA (OEM) M-460 (--- QTS)**

# OIL ANALYSIS REPORT

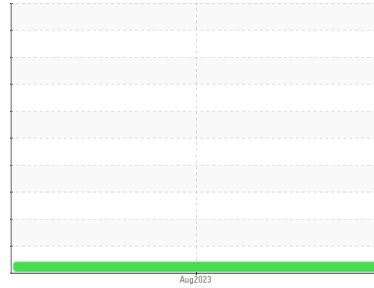
Sample Rating Trend

## VIS DEBRIS

Sample Status				<b>ABNORMAL</b>	---	---
Debris	scalar	*Visual	NONE	<b>▲ HEAVY</b>	---	---

No corrective action is recommended at this time. The filter change at the time of sampling has been noted. Resample at the next service interval to monitor. We were unable to perform a particle count due to a high concentration of particles present in this sample.

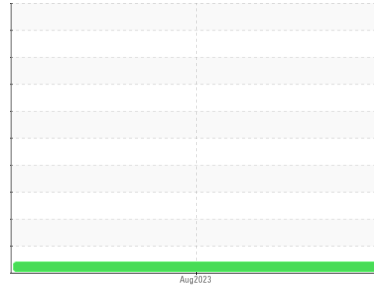
Sample Rating Trend

VIS DEBRIS

High concentration of visible dirt/debris present in the oil.

No corrective action is recommended at this time. The filter change at the time of sampling has been noted. Resample at the next service interval to monitor. We were unable to perform a particle count due to a high concentration of particles present in this sample.

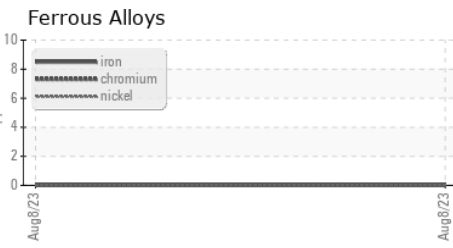
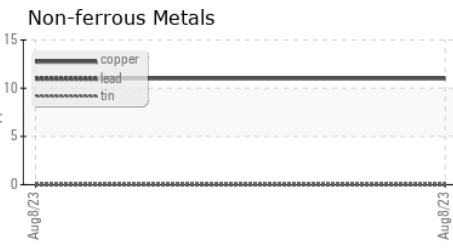
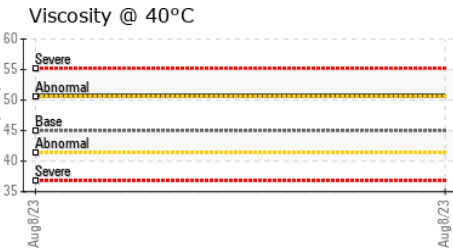
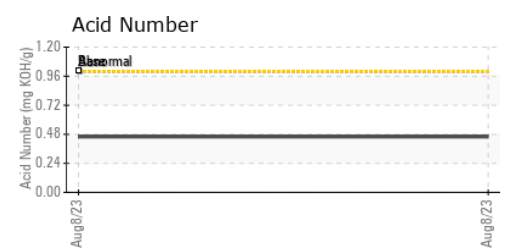
## GRAPHS

All component wear rates are normal.

The AN level is acceptable for this fluid. The condition of the oil is suitable for further service.

method	limit/base	current	history1	history2
Acid Number (AN)	mg KOH/g	ASTM D8045 1.0	<b>0.46</b>	---	---

FLUID PROPERTIES	method	limit/base	current	history1	history2
Visc @ 40°C	cSt	ASTM D445	45	<b>50.7</b>	---
