# OIL ANALYSIS REPORT

Area  
**37373 (TRACE PO 36880)**  
 Machine Id  
**08142023A - EGWTS0001**  
 Component  
**Hydraulic System**  
 Fluid  
**{not provided} (--- GAL)**

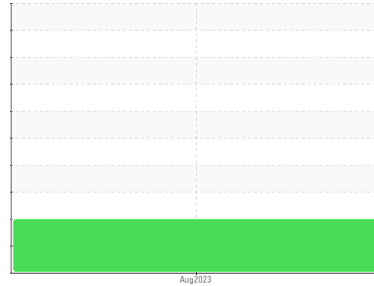
ISO

### ▲ Particle Count

Sample Status				ABNORMAL	---	---
Particles 5-15µm	count	*NAS 1638	>8000	▲ 161100	---	---
Particles 15-25µm	count	*NAS 1638	>1425	▲ 27400	---	---
Particles 25-50µm	count	*NAS 1638	>253	▲ 9200	---	---
Particles 50-100µm	count	*NAS 1638	>45	▲ 1400	---	---
Particles >100µm	count	*NAS 1638	>8	▲ 100	---	---

We advise that you perform a filter service, and use off-line filtration to improve the cleanliness of the system fluid.
