OIL ANALYSIS REPORT

Laboratory : WearCheck USA - 501 Madison Ave., Cary, NC 27513
Sample No. : USPM29252 **Received** : 18 Aug 2023
Lab Number : 05928264 **Diagnosed** : 21 Aug 2023
Unique Number : 10608211 **Diagnostician** : Doug Bogart
Test Package : IND 2

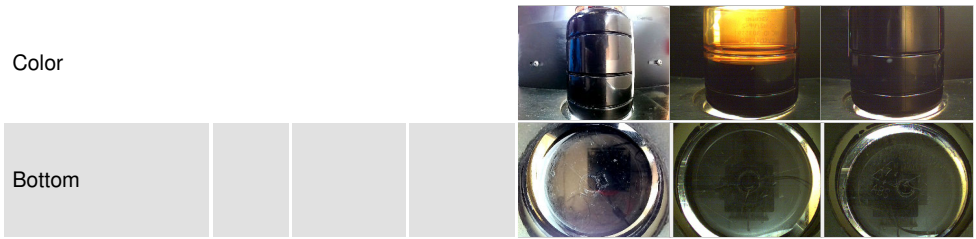
SAMPLE IMAGES	method	limit/base	current	history1	history2
---------------	--------	------------	---------	----------	----------

VISUAL	method	limit/base	current	history1	history2
White Metal	scalar	*Visual	NONE	NONE	LIGHT
Yellow Metal	scalar	*Visual	NONE	NONE	NONE
Precipitate	scalar	*Visual	NONE	NONE	NONE
Silt	scalar	*Visual	NONE	NONE	NONE
Debris	scalar	*Visual	NONE	LIGHT	NONE
Sand/Dirt	scalar	*Visual	NONE	NONE	NONE
Appearance	scalar	*Visual	NORML	NORML	NORML
Odor	scalar	*Visual	NORML	NORML	NORML
Emulsified Water	scalar	*Visual	NEG	NEG	NEG
Free Water	scalar	*Visual	NEG	NEG	NEG
