# PROBLEM SUMMARY

Area  
**IRON STAR [200006142]**  
 Machine Id  
**46WEA88312**  
 Component  
**Wind Turbine Gearbox**  
 Fluid  
**NOT GIVEN (--- LTR)**

# OIL ANALYSIS REPORT

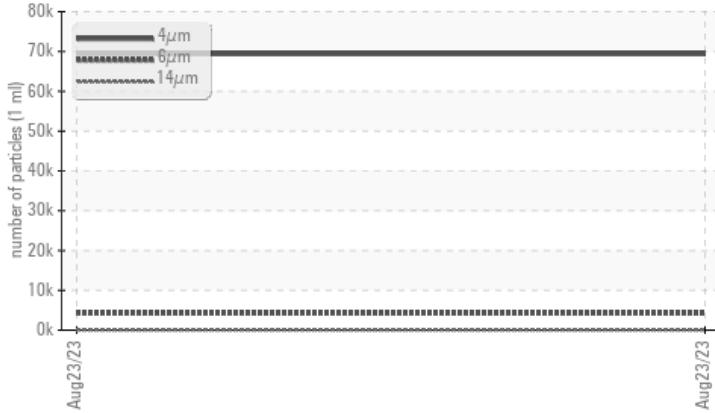
### ▲ Particle Trend

Sample Status			<b>ABNORMAL</b>	---	---
Particles >6µm	ASTM D7647	>1300	▲ <b>4239</b>	---	---
Oil Cleanliness	ISO 4406 (c)	>17/14	▲ <b>19/13</b>	---	---

No corrective action is recommended at this time.  
 Resample at the next service interval to monitor.
