PROBLEM SUMMARY

Area
IRON STAR [200006142]
 Machine Id
52WEA88336
 Component
Wind Turbine Gearbox
 Fluid
GEAR OIL (PAO) ISO 320 (--- LTR)

OIL ANALYSIS REPORT

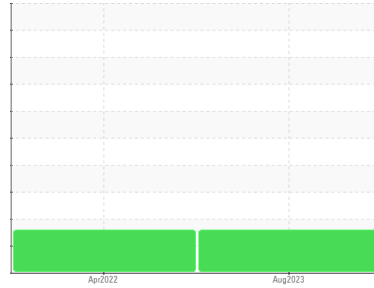
Sample Rating Trend

We recommend you service the filters on this component if applicable. Resample at the next service interval to monitor. All component wear rates are normal. There is a high amount of particulates present in the oil. The AN level is acceptable for this fluid. The condition of the oil is suitable for further service.

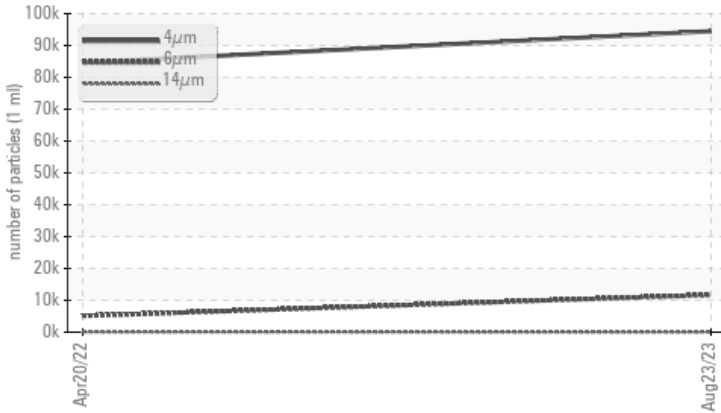
▲ Particle Trend

Sample Status			ABNORMAL	ABNORMAL	---
Particles >6µm	ASTM D7647	>320	▲ 11678	▲ 5093	---
Particles >14µm	ASTM D7647	>40	▲ 49	▲ 98	---
Particles >21µm	ASTM D7647	>10	▲ 12	▲ 24	---
Oil Cleanliness	ISO 4406 (c)	>--/15/12	▲ 24/21/13	▲ 24/20/14	---

There is a high amount of particulates present in the oil.

We recommend you service the filters on this component if applicable. Resample at the next service interval to monitor.

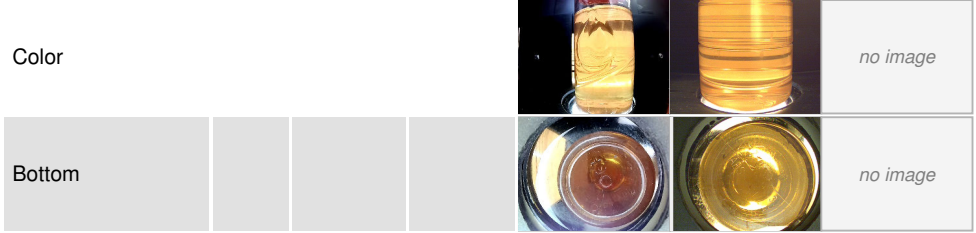
SAMPLE IMAGES

VISUAL	method	limit/base	current	history1	history2
White Metal	scalar	*Visual	NONE	NONE	---
Yellow Metal	scalar	*Visual	NONE	NONE	---
Precipitate	scalar	*Visual	NONE	NONE	---
Silt	scalar	*Visual	NONE	NONE	---
Debris	scalar	*Visual	NONE	NONE	---
Sand/Dirt	scalar	*Visual	NONE	NONE	---
Appearance	scalar	*Visual	NORML	NORML	---
Odor	scalar	*Visual	NORML	NORML	---
Emulsified Water	scalar	*Visual	>0.02	NEG	---
Free Water	scalar	*Visual		NEG	---

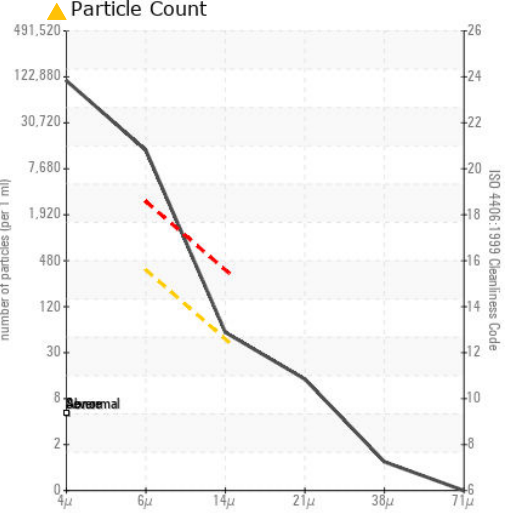
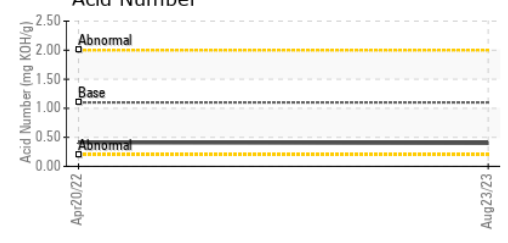
GRAPHS

method	limit/base	current	history1	history2
Particles >4µm	ASTM D7647		94481	84639	---
Particles >6µm	ASTM D7647	>320	▲ 11678	▲ 5093	---
Particles >14µm	ASTM D7647	>40	▲ 49	▲ 98	---
Particles >21µm	ASTM D7647	>10	▲ 12	▲ 24	---
Particles >38µm	ASTM D7647	>3	1	1	---
Particles >71µm	ASTM D7647	>3	0	0	---
Oil Cleanliness	ISO 4406 (c)	>--/15/12	▲ 24/21/13	▲ 24/20/14	---
