OIL ANALYSIS REPORT

Area
HAPL
 Machine Id
HAPL BRIDLE 2.2 (S/N 16-1100-0174)
 Component
Gearbox
 Fluid
NOT GIVEN (--- QTS)

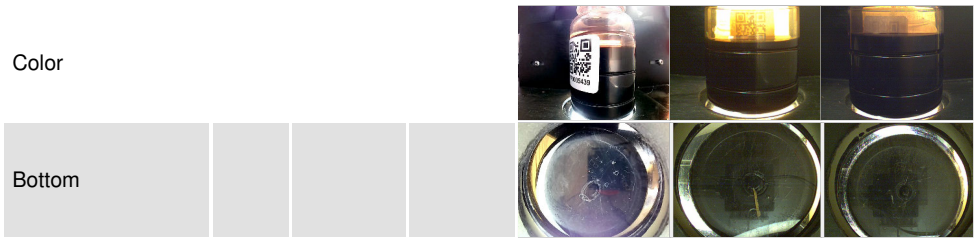
SAMPLE IMAGES	method	limit/base	current	history1	history2
---------------	--------	------------	---------	----------	----------

VISUAL	method	limit/base	current	history1	history2
White Metal	scalar	*Visual	NONE	NONE	NONE
Yellow Metal	scalar	*Visual	NONE	NONE	NONE
Precipitate	scalar	*Visual	NONE	NONE	NONE
Silt	scalar	*Visual	NONE	NONE	NONE
Debris	scalar	*Visual	NONE	NONE	NONE
Sand/Dirt	scalar	*Visual	NONE	NONE	NONE
Appearance	scalar	*Visual	NORML	NORML	NORML
Odor	scalar	*Visual	NORML	NORML	NORML
Emulsified Water	scalar	*Visual	>0.2	NEG	NEG
Free Water	scalar	*Visual		NEG	NEG

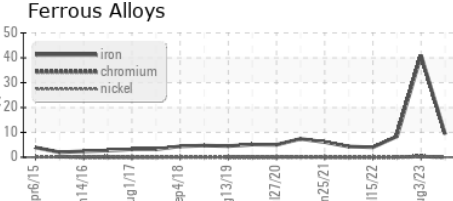
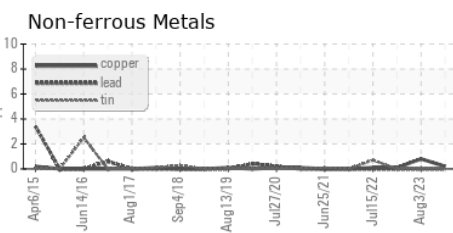
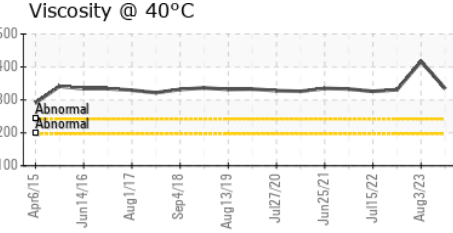
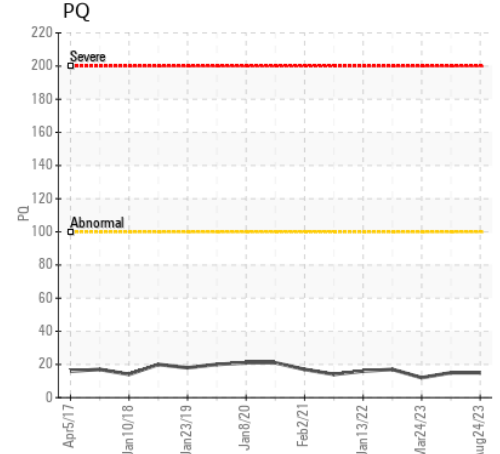
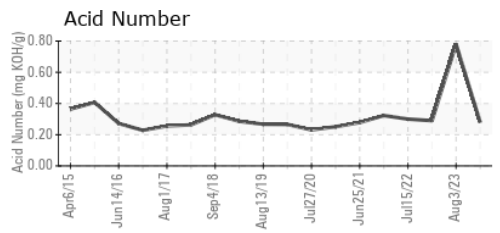
GRAPHS

All component wear rates are normal.

There is no indication of any contamination in the oil.

The AN level is acceptable for this fluid. The condition of the oil is suitable for further service.

Resample at the next service interval to monitor.
