# PROBLEM SUMMARY

Machine Id  
**1634**  
 Component  
**Compressor**  
 Fluid  
**KAESER SIGMA (OEM) S-460 (--- GAL)**

# OIL ANALYSIS REPORT

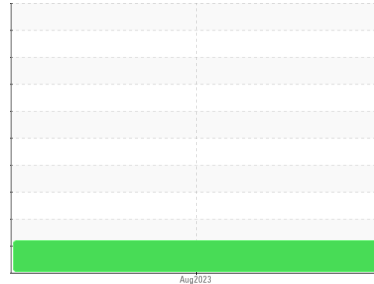
Sample Rating Trend

ISO

All component wear rates are normal.

The AN level is acceptable for this fluid. The condition of the oil is suitable for further service.

No corrective action is recommended at this time. The filter change at the time of sampling has been noted. Resample at the next service interval to monitor.
