Machine Id
KAESER AS 25T 9067174 (S/N 2049)
 Component
Compressor
 Fluid
KAESER SIGMA (OEM) S-460 (--- GAL)

Customer Id: CARMAD
 Sample No.: KCPA006104
 Lab Number: 05960689
 Test Package: IND 2

OIL ANALYSIS REPORT

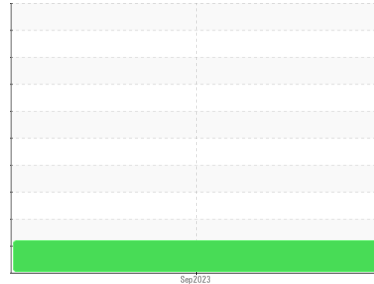
Sample Rating Trend

| Sample Status | | | | ATTENTION | --- | --- |
