# PROBLEM SUMMARY

Machine Id  
**R26**  
Component  
**Transmission (Auto)**  
Fluid  
**CASTROL TRANSYND 668 (--- GAL)**

# OIL ANALYSIS REPORT

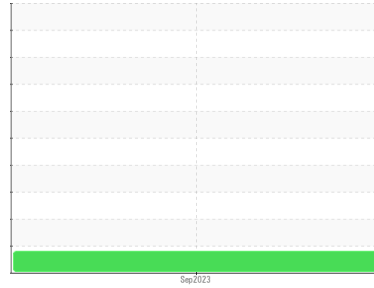
Sample Rating Trend

### ▲ Non-ferrous Metals

Sample Status				ABNORMAL	---	---
Lead	ppm	ASTM D5185m	>50	▲ 153	---	---

Oil and filter change at the time of sampling has been noted. Resample at the next service interval to monitor.

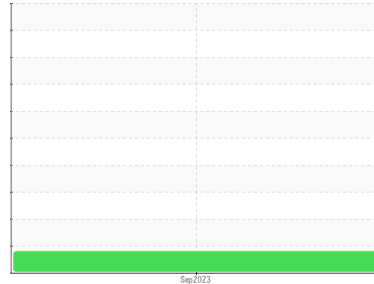
Clutch wear is indicated.

The condition of the fluid is acceptable for the time in service.

Oil and filter change at the time of sampling has been noted. Resample at the next service interval to monitor.
