# PROBLEM SUMMARY

Machine Id  
**AF12-240-M82119 PRESS BOTTOM RIGHT STEEL BELT DRIVE**  
 Component  
**Gear Drive**  
 Fluid  
**KLUBER Klubersynth GEM 4-320 N (--- GAL)**

# OIL ANALYSIS REPORT

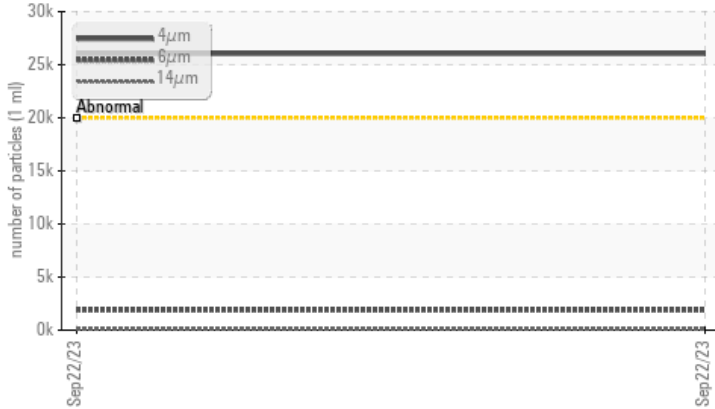
### ▲ Particle Trend

Sample Status			<b>ATTENTION</b>	---	---
Particles >4µm	ASTM D7647	>20000	▲ <b>26041</b>	---	---
Oil Cleanliness	ISO 4406 (c)	>21/19/16	▲ <b>22/18/14</b>	---	---

No corrective action is recommended at this time.  
 Resample at the next service interval to monitor.
