# PROBLEM SUMMARY

Area  
**STEAM AND POWER**  
 Machine Id  
**270.1575 PB10 CRUSHER ASH LUMP**  
 Component  
**Hydraulic Power Pack**  
 Fluid  
**AW HYDRAULIC OIL ISO 46 (--- GAL)**

# OIL ANALYSIS REPORT

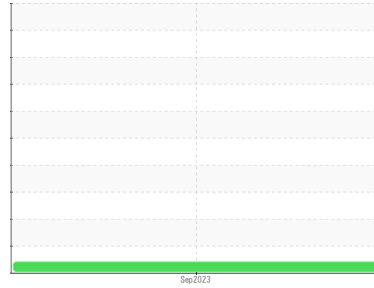
Sample Rating Trend

VIS DEBRIS

Sample Status				<b>ABNORMAL</b>	---	---
Debris	scalar	*Visual	NONE	<b>▲ MODER</b>	---	---

We recommend you service the filters on this component. Resample at the next service interval to monitor. We were unable to perform a particle count due to a high concentration of particles present in this sample.
