Machine Id  
**KAESER 8529611**

Component  
**Compressor**

Fluid  
**KAESER SIGMA (OEM) FG-460 (--- GAL)**

# OIL ANALYSIS REPORT

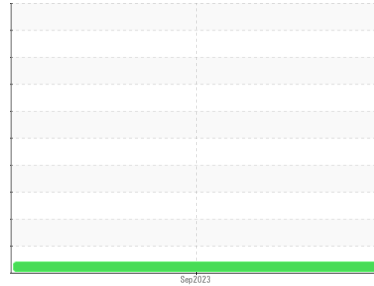
Sample Rating Trend

VIS DEBRIS

Moderate concentration of visible dirt/debris present in the oil.

The filter change at the time of sampling has been noted. Resample at the next service interval to monitor. We were unable to perform a particle count due to a high concentration of particles present in this sample.
