# OIL ANALYSIS REPORT

Machine Id  
**112002 - VOLVO EC350 EXCAVATOR (S/N 314101)**

Component  
**Hydraulic System**

Fluid  
**MOBIL DTE 10 EXCEL 46 (--- GAL)**

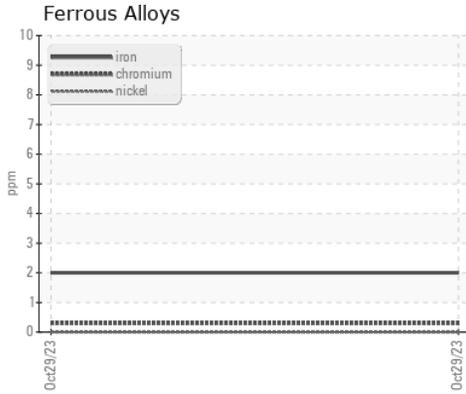
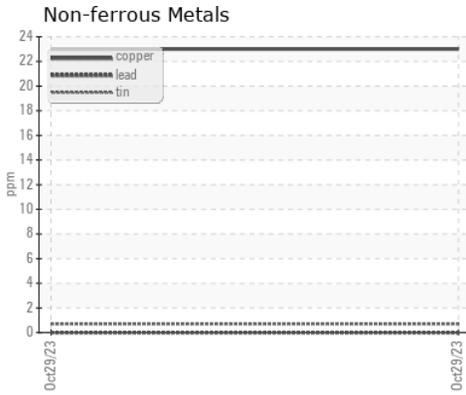
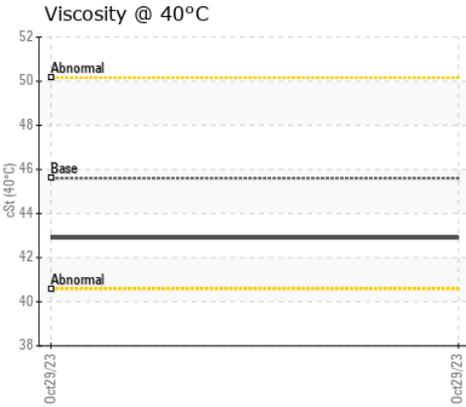
## GRAPHS

All component wear rates are normal.

There is no indication of any contamination in the oil.

The condition of the oil is acceptable for the time in service.

Resample at the next service interval to monitor.
