# PROBLEM SUMMARY

# OIL ANALYSIS REPORT

Area  
**MIXING**  
 Machine Id  
**[MIXING] HYDR\_002 HYDRAULIC UNIT (MIXER) MIX\_002**  
 Component  
**Hydraulic System**  
 Fluid  
**MOBIL DTE 10 EXCEL 46 (1250 LTR)**

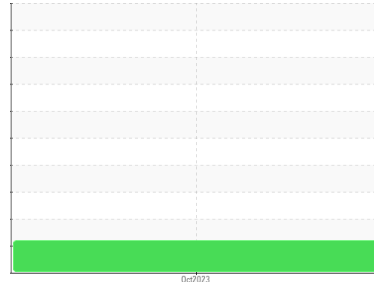
ISO

Sample Rating Trend

All component wear rates are normal.

The AN level is acceptable for this fluid. The condition of the oil is suitable for further service.

No corrective action is recommended at this time. Resample at the next service interval to monitor.
