# PROBLEM SUMMARY

Area  
**MIXING**  
 Machine Id  
**[MIXING] HYDR\_003 HYDRAULIC UNIT (MIXER\_003A) MIX\_003**  
 Component  
**Hydraulic System**  
 Fluid  
**MOBIL DTE 10 EXCEL 46 (800 LTR)**

# OIL ANALYSIS REPORT

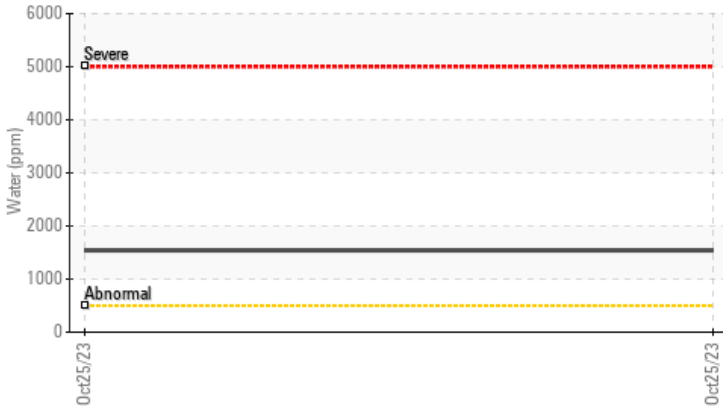
## COMPONENT CONDITION SUMMARY

▲ Water (KF)

Sample Status				<b>ABNORMAL</b>	---	---
Water	%	ASTM D6304	>0.05	▲ <b>0.154</b>	---	---
ppm Water	ppm	ASTM D6304	>500	▲ <b>1540</b>	---	---

There is a light concentration of water present in the oil. The amount and size of particulates present in the system are acceptable.

We recommend you service the filters on this component. Resample at the next service interval to monitor.
