Machine Id
GRINDER 3 (SOUTH PLANT)

Component
Gearbox

Fluid
JAX MAGNA-PLATE 220 FG (--- GAL)

OIL ANALYSIS REPORT

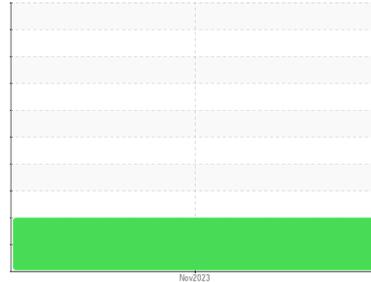
Sample Rating Trend

▲ Particle Trend

| Sample Status | | | ABNORMAL | --- | --- |
|---|---|---|---|---|---|
| Particles >4µm | ASTM D7647 | >20000 | ▲ 232155 | --- | --- |
| Particles >6µm | ASTM D7647 | >5000 | ▲ 159490 | --- | --- |
| Particles >14µm | ASTM D7647 | >640 | ▲ 9809 | --- | --- |
| Particles >21µm | ASTM D7647 | >160 | ▲ 746 | --- | --- |
| Oil Cleanliness | ISO 4406 (c) | >21/19/16 | ▲ 25/24/20 | --- | --- |

There is a high amount of particulates present in the oil.

We recommend you service the filters on this component if applicable. Resample at the next service interval to monitor.

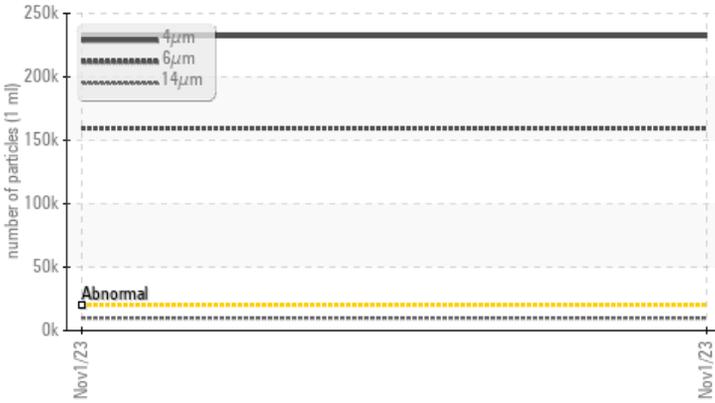
| method | limit/base | current | history1 | history2 |
|---|---|---|---|---|
| Particles >4µm ASTM D7647 | >20000 | ▲ 232155 | --- | --- |
| Particles >6µm ASTM D7647 | >5000 | ▲ 159490 | --- | --- |
| Particles >14µm ASTM D7647 | >640 | ▲ 9809 | --- | --- |
| Particles >21µm ASTM D7647 | >160 | ▲ 746 | --- | --- |
| Oil Cleanliness ISO 4406 (c) | >21/19/16 | ▲ 25/24/20 | --- | --- |

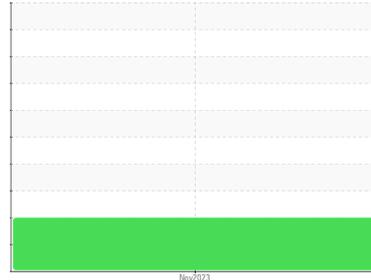
Sample Rating Trend

▲ Contamination

We recommend you service the filters on this component if applicable. Resample at the next service interval to monitor.
