**Customer Id:** AMELOC  
**Sample No.:** KCPA006966  
**Lab Number:** 05998456  
**Test Package:** IND 2

# OIL ANALYSIS REPORT

Machine Id  
**KAESER SK 15T 8666369 (S/N 1507)**  
 Component  
**Compressor**  
 Fluid  
**KAESER SIGMA (OEM) S-460 (--- GAL)**

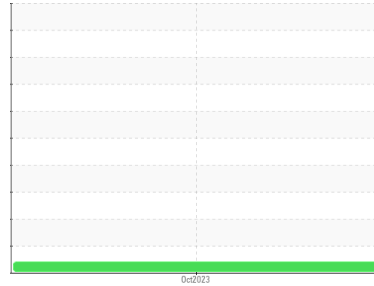
Sample Rating Trend

VIS DEBRIS

Sample Status				<b>ABNORMAL</b>	---	---
Debris	scalar	*Visual	NONE	<b>▲ MODER</b>	---	---

No corrective action is recommended at this time. The filter change at the time of sampling has been noted. Resample at the next service interval to monitor. We were unable to perform a particle count due to a high concentration of particles present in this sample.

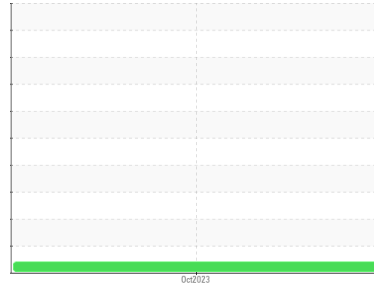
Sample Rating Trend

VIS DEBRIS

Moderate concentration of visible dirt/debris present in the oil.

No corrective action is recommended at this time. The filter change at the time of sampling has been noted. Resample at the next service interval to monitor. We were unable to perform a particle count due to a high concentration of particles present in this sample.
