Customer Id: MOTYOR
 Sample No.: WC0843820
 Lab Number: 05999176
 Test Package: IND 2

OIL ANALYSIS REPORT

Area
CRESLINE PLASTIC PIPE
 Machine Id
DISTRIBUTION 4 - CRESLINE PLASTIC PIPE
 Component
Gearbox
 Fluid
GEAR OIL ISO 460 (--- QTS)

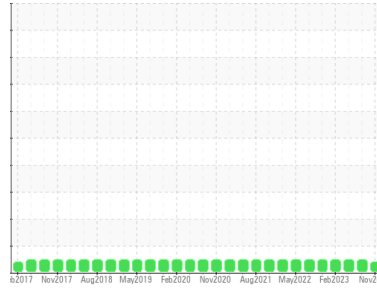
Sample Rating Trend

VIS DEBRIS

Sample Status		ABNORMAL	NORMAL	NORMAL
Debris	scalar *Visual	▲ MODER	LIGHT	LIGHT

Resample at the next service interval to monitor.

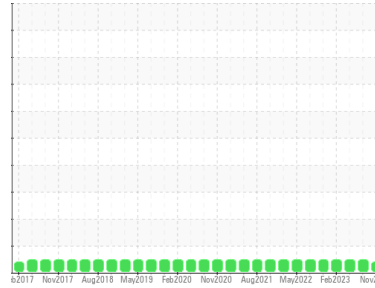
Sample Rating Trend

Wear
 All component wear rates are normal.

Contamination
 Moderate concentration of visible dirt/debris present in the oil.

Fluid Condition
 The AN level is acceptable for this fluid. The condition of the oil is suitable for further service.

Recommendation
 Resample at the next service interval to monitor.
