Customer Id: NRGDOV
Sample No.: USP249791
Lab Number: 06006376
Test Package: IND 2

OIL ANALYSIS REPORT

Machine Id
KD-1 GAS NOX PUMP
 Component
Gearbox
 Fluid
MOBIL SHC 630 (--- GAL)

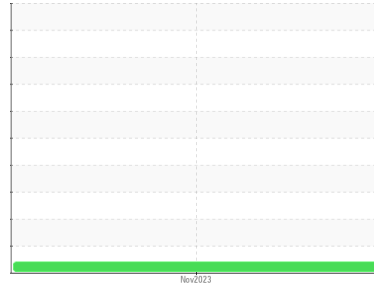
Sample Rating Trend

VIS DEBRIS

Moderate concentration of visible dirt/debris present in the oil.

We recommend you service the filters on this component if applicable. Resample at the next service interval to monitor. We were unable to perform a particle count due to a high concentration of particles present in this sample.

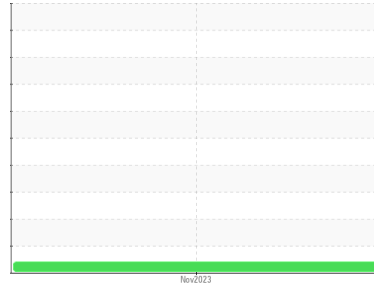
Sample Rating Trend

VIS DEBRIS

We recommend you service the filters on this component if applicable. Resample at the next service interval to monitor. We were unable to perform a particle count due to a high concentration of particles present in this sample.

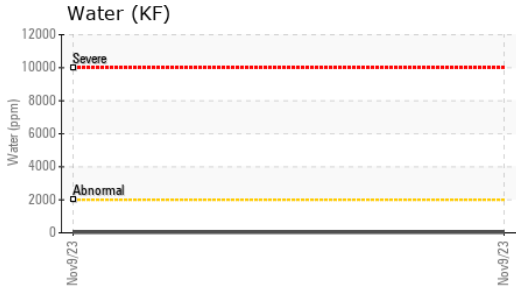
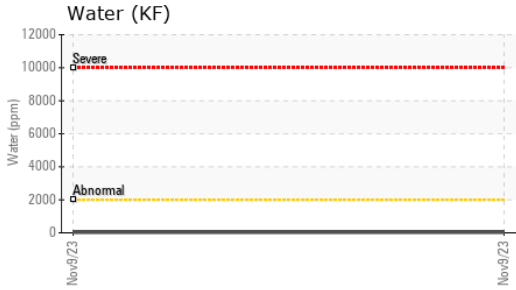
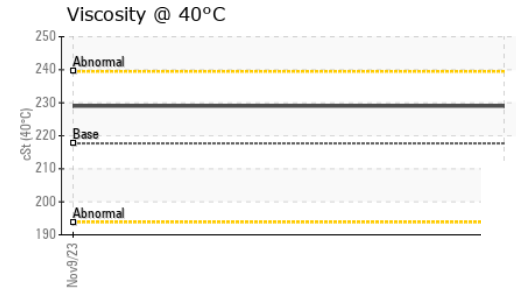
SAMPLE IMAGES	method	limit/base	current	history1	history2
Color					
Bottom

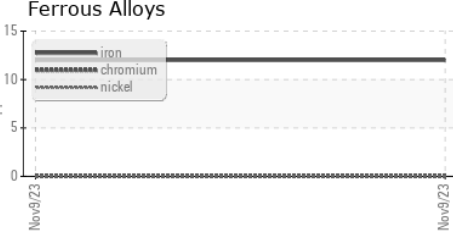
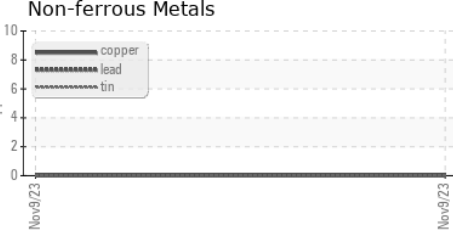
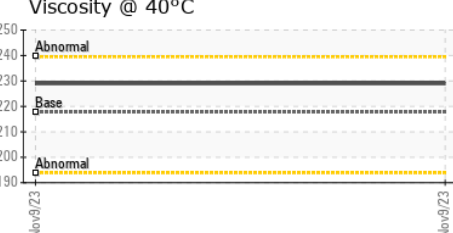
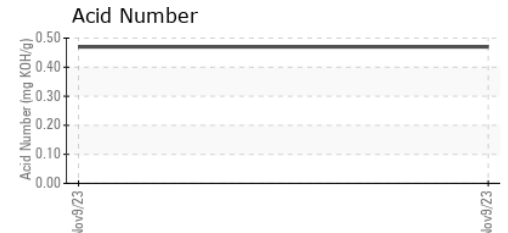
GRAPHS

All component wear rates are normal.

The AN level is acceptable for this fluid. The condition of the oil is suitable for further service.
