# OIL ANALYSIS REPORT

Machine Id  
**E 0110A E 0110A**

Component  
**Diesel Engine**

Fluid  
**DIESEL ENGINE OIL SAE 15W40 (--- GAL)**

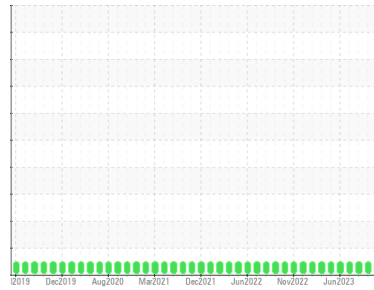
## Sample Rating Trend

**NORMAL**

All component wear rates are normal.

There is no indication of any contamination in the oil.

The BN result indicates that there is suitable alkalinity remaining in the oil. The condition of the oil is suitable for further service.

Resample at the next service interval to monitor.
