# OIL ANALYSIS REPORT

Machine Id  
**KAESER 5339184 - PRECISION GRANITE AND MAR (S/N 1088)**

Component  
**Compressor**  
Fluid  
**NOT GIVEN (--- GAL)**

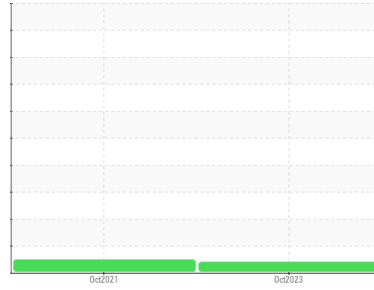
Sample Rating Trend

**VIS DEBRIS**

Sample Status				<b>ABNORMAL</b>	NORMAL	---
Debris	scalar	*Visual	NONE	<b>▲ MODER</b>	LIGHT	---

Oil and filter change at the time of sampling has been noted. Resample at the next service interval to monitor.

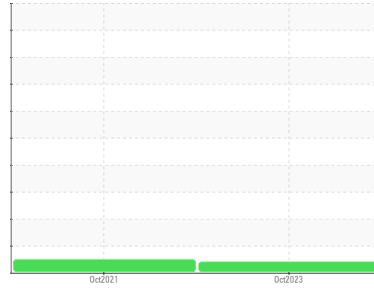
Sample Rating Trend

VIS DEBRIS

Moderate concentration of visible dirt/debris present in the oil.

Oil and filter change at the time of sampling has been noted. Resample at the next service interval to monitor.

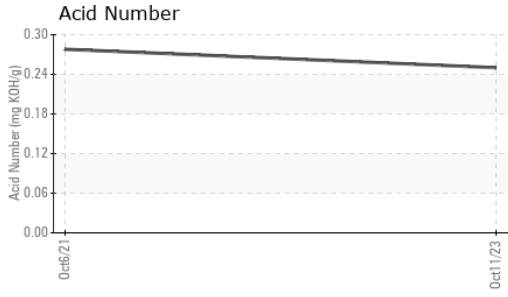
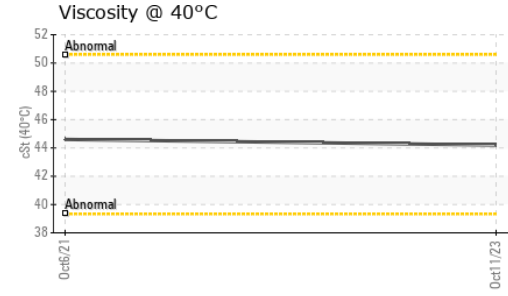
VISUAL	method	limit/base	current	history1	history2
White Metal	scalar	*Visual	NONE	NONE	---
Yellow Metal	scalar	*Visual	NONE	NONE	---
Precipitate	scalar	*Visual	NONE	NONE	---
Silt	scalar	*Visual	NONE	NONE	---
Debris	scalar	*Visual	NONE	▲ MODER	LIGHT
Sand/Dirt	scalar	*Visual	NONE	NONE	---
Appearance	scalar	*Visual	NORML	NORML	---
Odor	scalar	*Visual	NORML	NORML	---
Emulsified Water	scalar	*Visual	>0.05	NEG	---
Free Water	scalar	*Visual		NEG	---
