OIL ANALYSIS REPORT

Machine Id
1203
 Component
Transmission
 Fluid
NOT GIVEN (--- GAL)

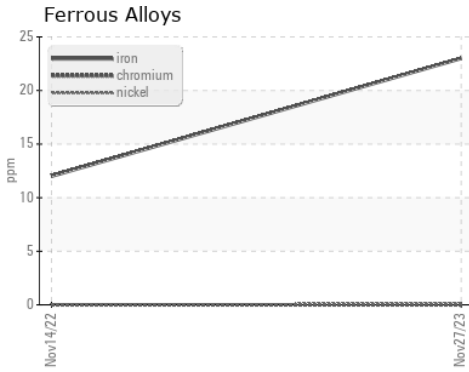
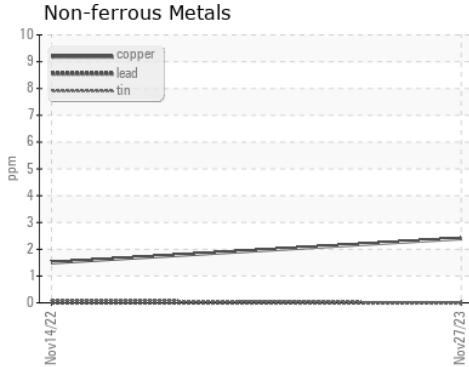
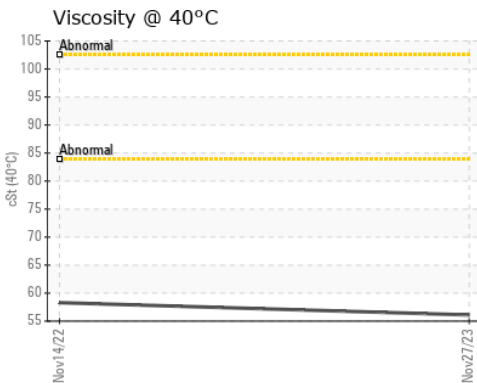
GRAPHS

All component wear rates are normal.

There is no indication of any contamination in the fluid.

The condition of the fluid is acceptable for the time in service.

Resample at the next service interval to monitor.
