Machine Id
MAZAK NEXUS 450II-MY
Component
Hydraulic System
Fluid
MOBIL DTE ULTRA 24 ISO 32 (--- GAL)

Customer Id: LINORA
Sample No.: PH0003684
Lab Number: 06029985
Test Package: PLANT

OIL ANALYSIS REPORT

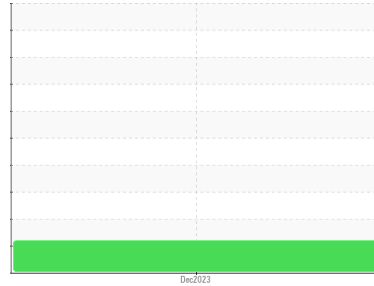
Sample Rating Trend

▲ Particle Trend

| Particles >4µm | ASTM D7647 | >10000 | ▲ 14350 | --- | --- | --- |
| Particles >6µm | ASTM D7647 | >2500 | ▲ 3513 | --- | --- | --- |
| Oil Cleanliness | ISO 4406 (c) | >20/18/15 | ▲ 21/19/15 | --- | --- | --- |

No corrective action is recommended at this time.
Resample at the next service interval to monitor.

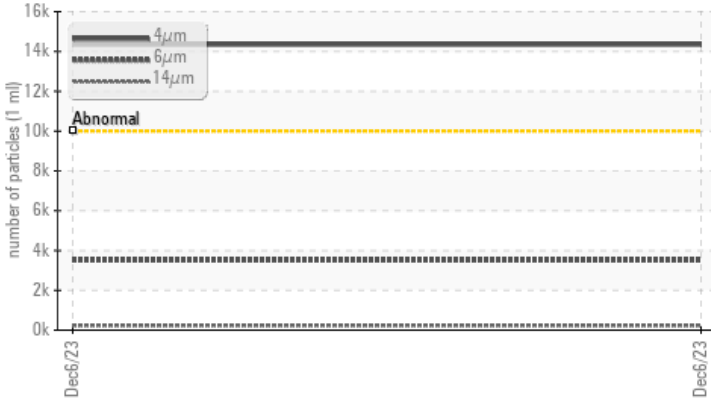
There is a moderate amount of silt (particulates < 14 microns in size) present in the oil.

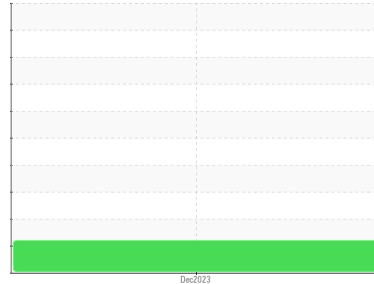
Sample Rating Trend

▲ Contamination

No corrective action is recommended at this time. Resample at the next service interval to monitor.
