Area
CSC NORTH [FA-8701]
 Machine Id
FRICK COMPRESSOR 1 - CSC NORTH (S/N 1051F)
 Component
Screw Compressor
 Fluid
SUMMIT RHT-68 (--- GAL)

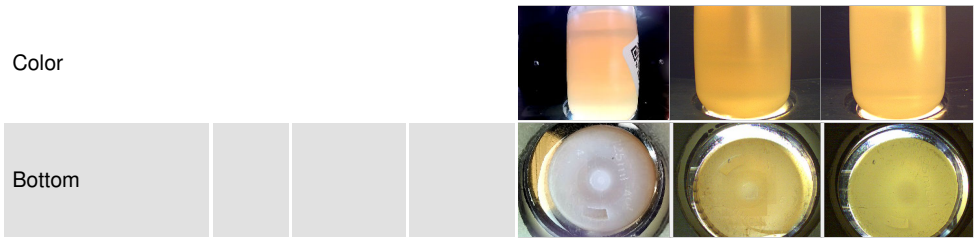
| SAMPLE IMAGES | method | limit/base | current | history1 | history2 |

| VISUAL | method | limit/base | current | history1 | history2 |
|---|---|---|---|---|---|
| Appearance | scalar | *Visual | NORML | NORML | NORML |
| Odor | scalar | *Visual | NORML | NORML | NORML |
