Laboratory : WearCheck USA - 501 Madison Ave., Cary, NC 27513
Sample No. : NX012337
Lab Number : 06097725
Unique Number : 10890578
Test Package : IND 2 (Additional Tests: KF, PQ, PrtCount)

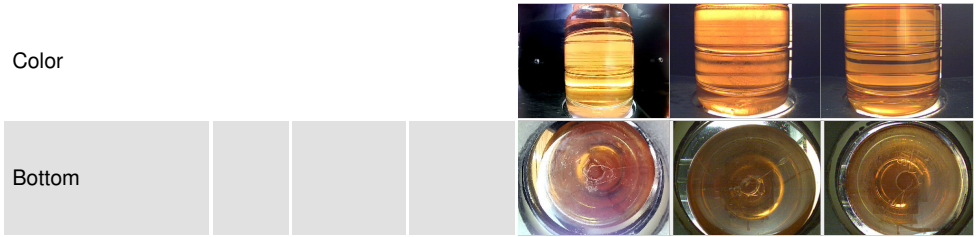
SAMPLE IMAGES	method	limit/base	current	history1	history2
---------------	--------	------------	---------	----------	----------
