# OIL ANALYSIS REPORT

**Laboratory** : WearCheck USA - 501 Madison Ave., Cary, NC 27513  
**Sample No.** : WC0888215  
**Lab Number** : 06130549  
**Unique Number** : 10950014  
**Test Package** : CONST  
**Received** : 27 Mar 2024  
**Tested** : 28 Mar 2024  
**Diagnosed** : 30 Mar 2024 - Don Baldrige

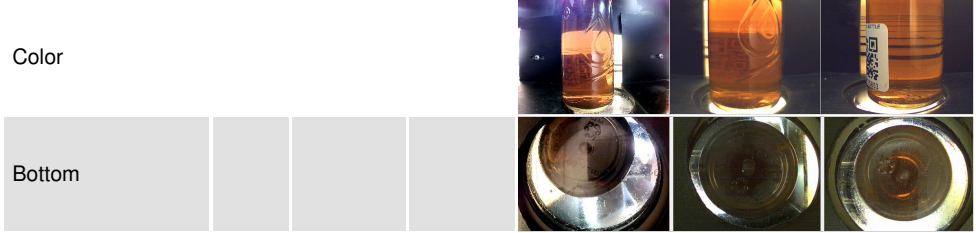
SAMPLE IMAGES	method	limit/base	current	history1	history2
---------------	--------	------------	---------	----------	----------

VISUAL	method	limit/base	current	history1	history2
White Metal	scalar	*Visual	NONE	NONE	NONE
Yellow Metal	scalar	*Visual	NONE	NONE	NONE
Precipitate	scalar	*Visual	NONE	NONE	NONE
Silt	scalar	*Visual	NONE	NONE	NONE
Debris	scalar	*Visual	NONE	NONE	NONE
Sand/Dirt	scalar	*Visual	NONE	NONE	NONE
Appearance	scalar	*Visual	NORML	NORML	NORML
Odor	scalar	*Visual	NORML	NORML	NORML
Emulsified Water	scalar	*Visual	>0.1	NEG	0.2%
Free Water	scalar	*Visual		NEG	NEG
