OIL ANALYSIS REPORT

Machine Id
SCREEN 5

Component
Rear Gearbox

Fluid
JAX SYNGEAR INDUSTRIAL GEAR ISO 220 (--- GAL)

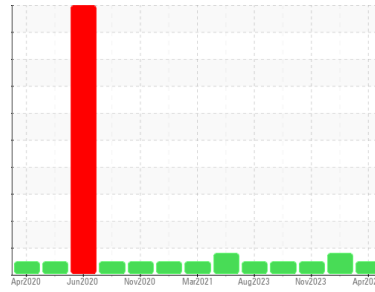
Sample Rating Trend

NORMAL

All component wear rates are normal.

There is no indication of any contamination in the oil.

The condition of the oil is acceptable for the time in service.

Resample at the next service interval to monitor.
