OIL ANALYSIS REPORT

Laboratory : WearCheck USA - 501 Madison Ave., Cary, NC 27513
Sample No. : KCPA016322 **Received** : 08 Apr 2024
Lab Number : 06142292 **Tested** : 09 Apr 2024
Unique Number : 10967100 **Diagnosed** : 11 Apr 2024 - Don Baldrige
Test Package : IND 2 (Additional Tests: KF, PrtCount)

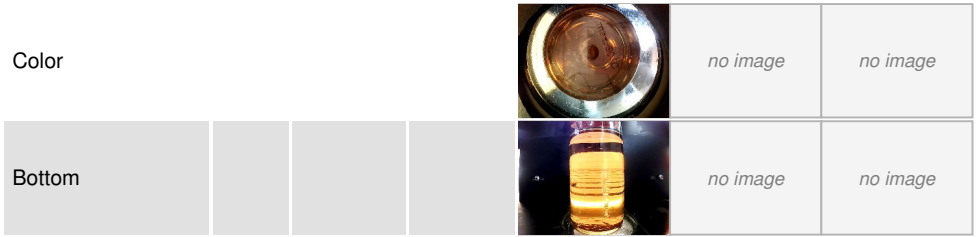
SAMPLE IMAGES	method	limit/base	current	history1	history2
---------------	--------	------------	---------	----------	----------

VISUAL	method	limit/base	current	history1	history2
White Metal	scalar	*Visual	NONE	NONE	---
Yellow Metal	scalar	*Visual	NONE	NONE	---
Precipitate	scalar	*Visual	NONE	NONE	---
Silt	scalar	*Visual	NONE	NONE	---
Debris	scalar	*Visual	NONE	LIGHT	---
Sand/Dirt	scalar	*Visual	NONE	NONE	---
Appearance	scalar	*Visual	NORML	NORML	---
Odor	scalar	*Visual	NORML	NORML	---
Emulsified Water	scalar	*Visual	>0.05	NEG	---
Free Water	scalar	*Visual		NEG	---
