OIL ANALYSIS REPORT

Laboratory : WearCheck USA - 501 Madison Ave., Cary, NC 27513
Sample No. : NX06151090 **Received** : 16 Apr 2024
Lab Number : 06151090 **Tested** : 17 Apr 2024
Unique Number : 10981168 **Diagnosed** : 19 Apr 2024 - Don Baldrige
Test Package : IND 2 (Additional Tests: KF, PQ)

NORDEX USA - Chicago
 300 SOUTH WACKER DRIVE, SUITE 1500
 CHICAGO, IL
 US 60606
 Contact: KEVIN REGAN
 KRegan@nordex-online.com

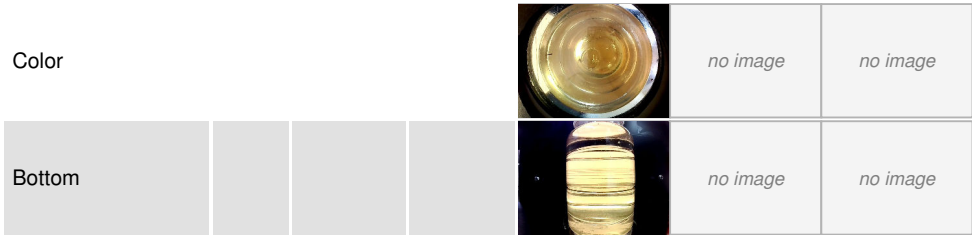
SAMPLE IMAGES	method	limit/base	current	history1	history2
---------------	--------	------------	---------	----------	----------

VISUAL	method	limit/base	current	history1	history2	
White Metal	scalar	*Visual	NONE	NONE	---	---
Yellow Metal	scalar	*Visual	NONE	NONE	---	---
Precipitate	scalar	*Visual	NONE	NONE	---	---
Silt	scalar	*Visual	NONE	NONE	---	---
Debris	scalar	*Visual	NONE	LIGHT	---	---
Sand/Dirt	scalar	*Visual	NONE	NONE	---	---
Appearance	scalar	*Visual	NORML	NORML	---	---
Odor	scalar	*Visual	NORML	NORML	---	---
Emulsified Water	scalar	*Visual	>0.05	NEG	---	---
Free Water	scalar	*Visual		NEG	---	---
