OIL ANALYSIS REPORT

Laboratory : WearCheck USA - 501 Madison Ave., Cary, NC 27513
Sample No. : KCPA013732 **Received** : 17 Apr 2024
Lab Number : 06152597 **Tested** : 22 Apr 2024
Unique Number : 10982675 **Diagnosed** : 22 Apr 2024 - Don Baldrige
Test Package : IND 2 (Additional Tests: KF, PrtCount)

WINSLOW AUTOMATION INC
 905 MONTAGUE EXPY
 MILPITAS, CA
 US 95035
 Contact: CARLOS
 carlos@solderquik.com

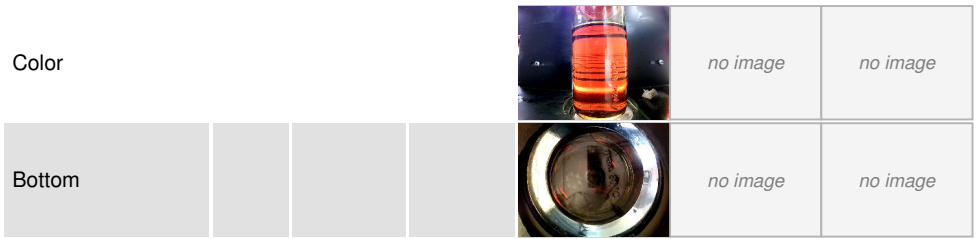
SAMPLE IMAGES	method	limit/base	current	history1	history2
---------------	--------	------------	---------	----------	----------

VISUAL	method	limit/base	current	history1	history2
White Metal	scalar	*Visual	NONE	NONE	---
Yellow Metal	scalar	*Visual	NONE	NONE	---
Precipitate	scalar	*Visual	NONE	NONE	---
Silt	scalar	*Visual	NONE	NONE	---
Debris	scalar	*Visual	NONE	NONE	---
Sand/Dirt	scalar	*Visual	NONE	NONE	---
Appearance	scalar	*Visual	NORML	NORML	---
Odor	scalar	*Visual	NORML	NORML	---
Emulsified Water	scalar	*Visual	>0.05	NEG	---
Free Water	scalar	*Visual		NEG	---
