PROBLEM SUMMARY

Machine Id
PALFINGER 100415601 - GERREIN GREEN
 Component
Hydraulic System
 Fluid
AW HYDRAULIC OIL ISO 32 (--- LTR)

OIL ANALYSIS REPORT

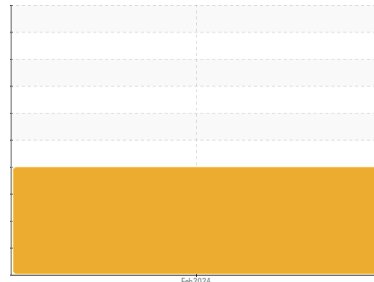
Sample Rating Trend

Sample Status			SEVERE	---	---
Particles >4µm	ASTM D7647	>5000	▲ 82717	---	---
Particles >6µm	ASTM D7647	>1300	▲ 18855	---	---
Oil Cleanliness	ISO 4406 (c)	>19/17/14	▲ 24/21/15	---	---
