OIL ANALYSIS REPORT

Area
DEBARKING WASTE
 Machine Id
Waste Shredder (S/N DW205H82)
 Component
Hydraulic System
 Fluid
SHELL TELLUS S2 M 68 (150 GAL)

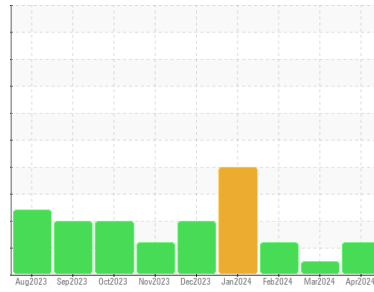
Sample Rating Trend

There is a light amount of silt (particulates < 14 microns in size) present in the oil.

We recommend you service the filters on this component. Resample at the next service interval to monitor.

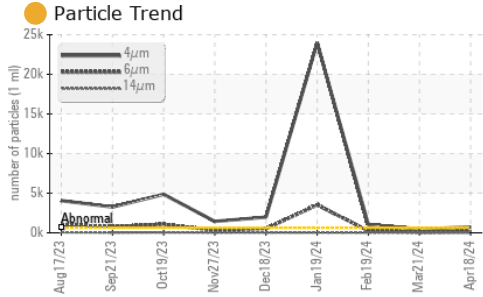
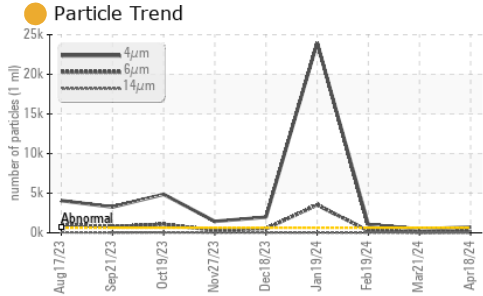
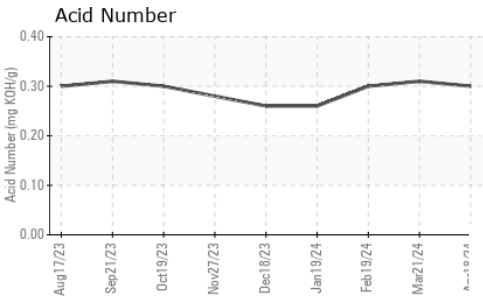
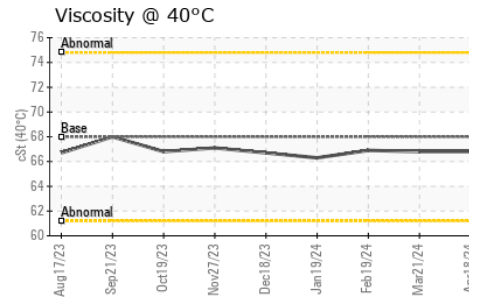
| FLUID CLEANLINESS | | method | limit/base | current | history1 | history2 |
|---|--|---|---|---|---|---|
| Oil Cleanliness | | ISO 4406 (c) | >16/14/11 | 17/15/10 | 16/14/10 | 17/15/11 |

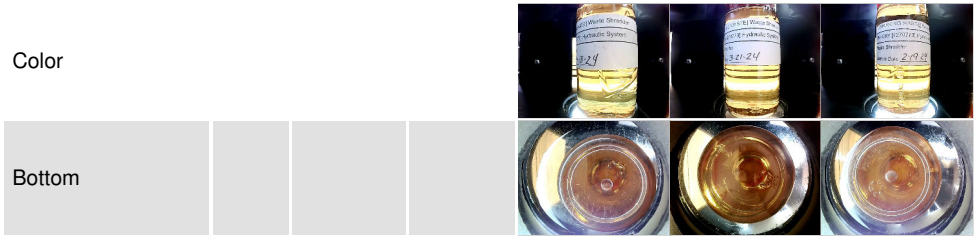
| SAMPLE IMAGES | method | limit/base | current | history1 | history2 |

| VISUAL | method | limit/base | current | history1 | history2 |
|---|---|---|---|---|---|
| Silt | scalar | *Visual | NONE | NONE | NONE |
| Debris | scalar | *Visual | NONE | NONE | NONE |
| Appearance | scalar | *Visual | NORML | NORML | NORML |
