Machine Id  
**BOBSP 7304**  
 Component  
**Hydraulic System**  
 Fluid  
 {not provided} (--- GAL)

# OIL ANALYSIS REPORT

**Laboratory** : WearCheck USA - 501 Madison Ave., Cary, NC 27513  
**Sample No.** : PTK0001401  
**Lab Number** : 06159781  
**Unique Number** : 10995204  
**Test Package** : MOB 2

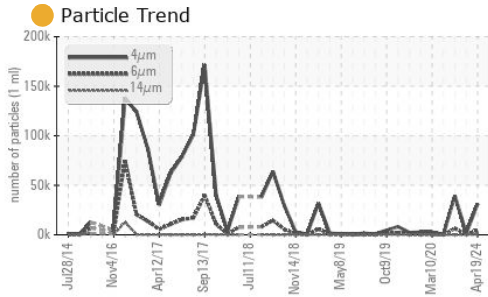
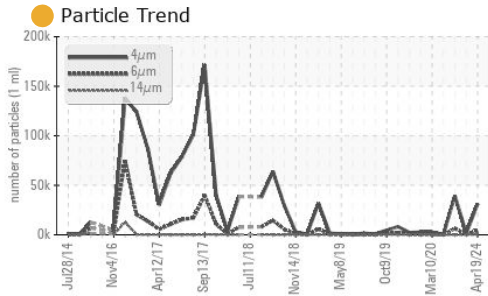
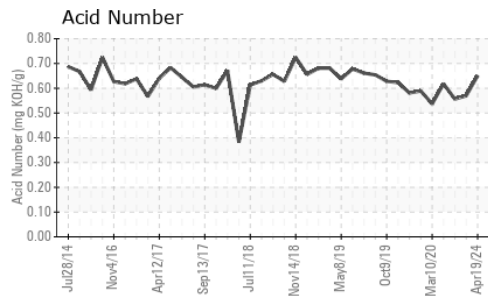
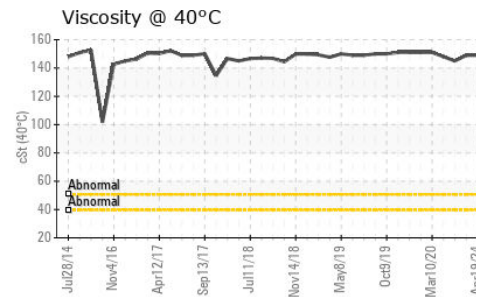
## GRAPHS

All component wear rates are normal.

There is a light amount of silt (particulates < 14 microns in size) present in the oil.

The AN level is acceptable for this fluid. The condition of the oil is suitable for further service.

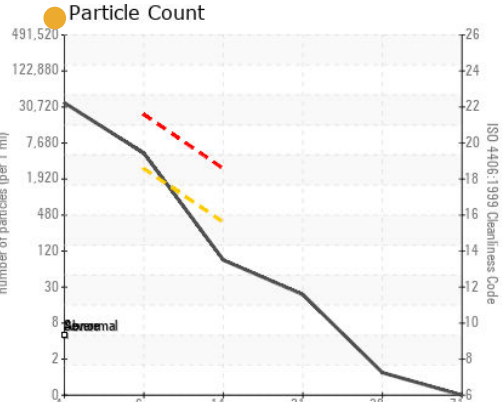
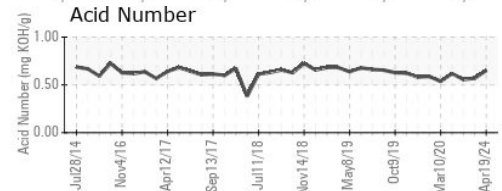
FLUID CLEANLINESS		method	limit/base	current	history1	history2
Particles >4µm		ASTM D7647		<b>31209</b>	1513	39560
Particles >6µm		ASTM D7647	>2500	<b>4525</b>	451	▲ 6414
Particles >14µm		ASTM D7647	>320	<b>75</b>	51	97
Particles >21µm		ASTM D7647	>80	<b>20</b>	21	20
Particles >38µm		ASTM D7647	>20	<b>1</b>	3	1
Particles >71µm		ASTM D7647	>4	<b>0</b>	1	0
Oil Cleanliness		ISO 4406 (c)	>18/15	<b>19/13</b>	16/13	▲ 22/20/14

We recommend you service the filters on this component. Resample at the next service interval to monitor. Please specify the brand, type, and viscosity of the oil on your next sample.
