OIL ANALYSIS REPORT

Laboratory : WearCheck USA - 501 Madison Ave., Cary, NC 27513
Sample No. : KCPA012499 **Received** : 09 May 2024
Lab Number : **06174627** **Tested** : 15 May 2024
Unique Number : 11020680 **Diagnosed** : 15 May 2024 - Don Baldrige
Test Package : IND 2 (Additional Tests: KF, PrtCount)

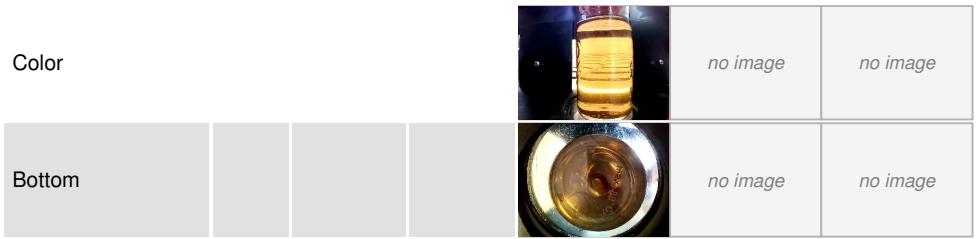
SAMPLE IMAGES	method	limit/base	current	history1	history2
---------------	--------	------------	---------	----------	----------

VISUAL	method	limit/base	current	history1	history2
White Metal	scalar	*Visual	NONE	NONE	---
Yellow Metal	scalar	*Visual	NONE	NONE	---
Precipitate	scalar	*Visual	NONE	NONE	---
Silt	scalar	*Visual	NONE	NONE	---
Debris	scalar	*Visual	NONE	NONE	---
Sand/Dirt	scalar	*Visual	NONE	NONE	---
Appearance	scalar	*Visual	NORML	NORML	---
Odor	scalar	*Visual	NORML	NORML	---
Emulsified Water	scalar	*Visual	>0.05	NEG	---
Free Water	scalar	*Visual		NEG	---

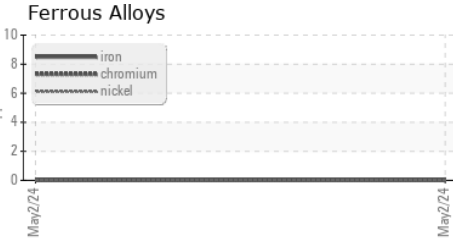
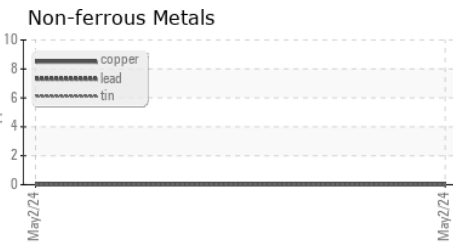
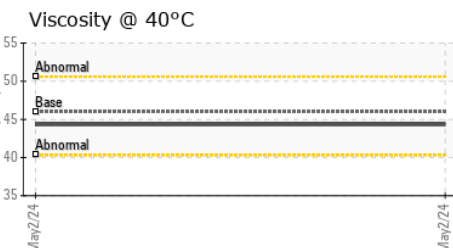
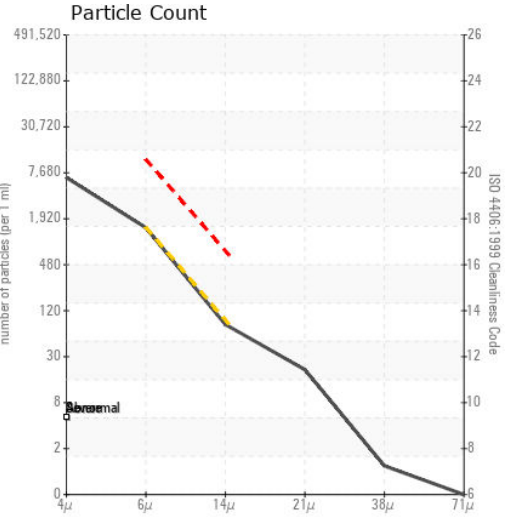
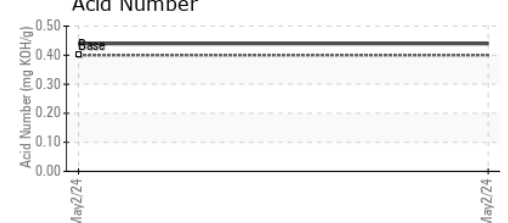
GRAPHS

FLUID PROPERTIES	method	limit/base	current	history1	history2
Visc @ 40°C	cSt	ASTM D445	46	44.33	---
