OIL ANALYSIS REPORT

Laboratory : WearCheck USA - 501 Madison Ave., Cary, NC 27513
Sample No. : KC129428
Lab Number : 06177714
Unique Number : 11023767
Test Package : IND 2

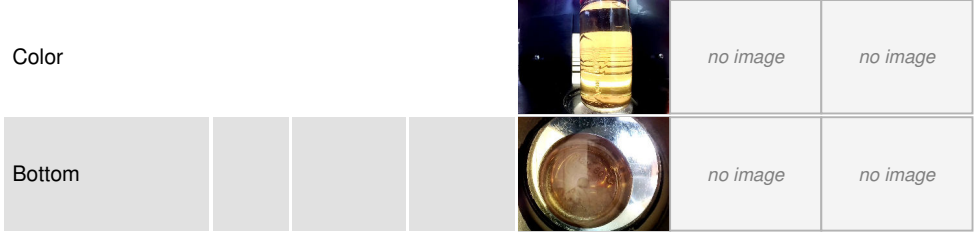
SAMPLE IMAGES	method	limit/base	current	history1	history2
---------------	--------	------------	---------	----------	----------

VISUAL	method	limit/base	current	history1	history2
White Metal	scalar	*Visual	NONE	NONE	---
Yellow Metal	scalar	*Visual	NONE	NONE	---
Precipitate	scalar	*Visual	NONE	NONE	---
Silt	scalar	*Visual	NONE	NONE	---
Debris	scalar	*Visual	NONE	NONE	---
Sand/Dirt	scalar	*Visual	NONE	NONE	---
Appearance	scalar	*Visual	NORML	NORML	---
Odor	scalar	*Visual	NORML	NORML	---
Emulsified Water	scalar	*Visual	>0.05	NEG	---
Free Water	scalar	*Visual		NEG	---
