PALFINGER 100453650

Hydraulic System

AW HYDRAULIC OIL ISO 32 (--- GAL)

OIL ANALYSIS REPORT

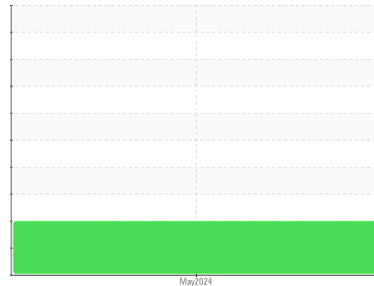
Sample Rating Trend

▲ Particle Trend

Sample Status			SEVERE	---	---
Particles >4µm	ASTM D7647	>5000	▲ 54924	---	---
Particles >6µm	ASTM D7647	>1300	▲ 4874	---	---
Oil Cleanliness	ISO 4406 (c)	>19/17/14	▲ 23/19/14	---	---

Check seals and/or filters for points of contaminant entry. The air breather requires service. If unrated, we recommend that you replace with a suitable micron rated and/or desiccant air breather. If rated, we recommend that you service/replace the breather. We recommend you service the filters on this component. Resample in 30-45 days to monitor this situation. The fluid was not specified, however, a fluid match indicates that this fluid is (GENERIC) AW HYDRAULIC OIL ISO 32. Please confirm.

Action	Status	Date	Done By	Description
Change Filter	---	---	?	We recommend you service the filters on this component.
Resample	---	---	?	Resample in 30-45 days to monitor this situation.
Alert	---	---	?	The fluid was not specified, however, a fluid match indicates that this fluid is (GENERIC) AW HYDRAULIC OIL ISO 32. Please confirm.
Information Required	---	---	?	The fluid was not specified, however, a fluid match indicates that this fluid is (GENERIC) AW HYDRAULIC OIL ISO 32. Please confirm.
Check Breathers	---	---	?	The air breather requires service. If unrated, we recommend that you replace with a suitable micron rated and/or desiccant air breather. If rated, we recommend that you service/replace the breather.
Check Seals	---	---	?	Check seals and/or filters for points of contaminant entry.
