**Laboratory** : WearCheck USA - 501 Madison Ave., Cary, NC 27513  
**Sample No.** : USP0011474  
**Lab Number** : 06180193  
**Unique Number** : 11031519  
**Test Package** : IND 2

**KraftHeinz - Lowville - Plant 8322 USP**  
 7388 UTICA BLVD  
 LOWVILLE, NY  
 US 13367  
 Contact: Service Manager

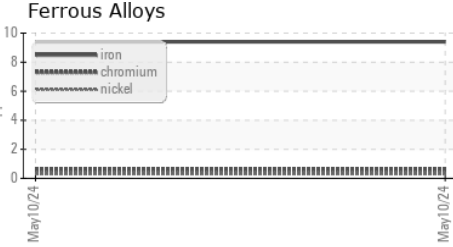
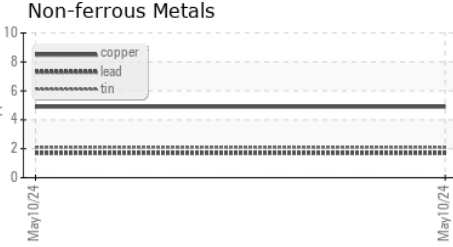
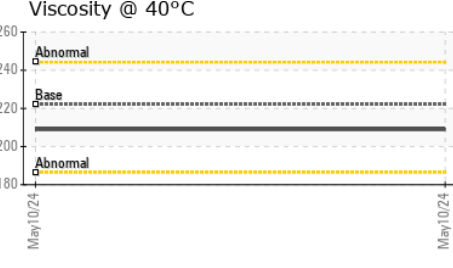
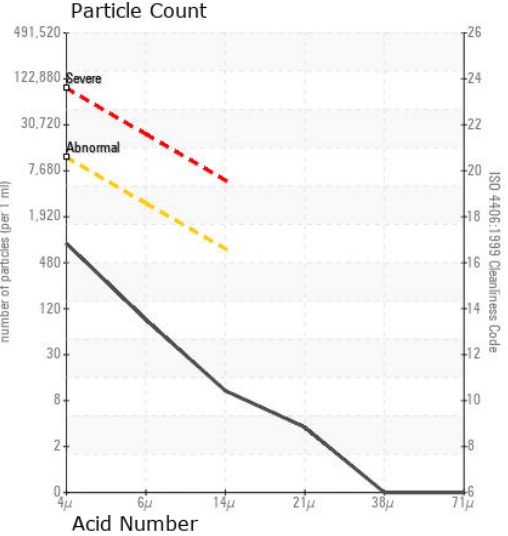
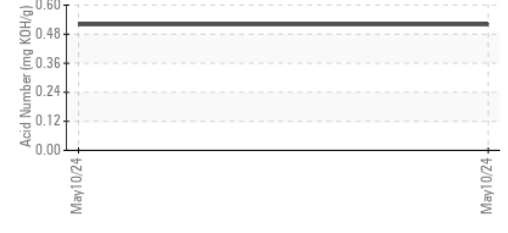
## GRAPHS

VISUAL	method	limit/base	current	history1	history2	
White Metal	scalar	*Visual	NONE	NONE	---	---
Yellow Metal	scalar	*Visual	NONE	NONE	---	---
Precipitate	scalar	*Visual	NONE	NONE	---	---
Silt	scalar	*Visual	NONE	NONE	---	---
Debris	scalar	*Visual	NONE	NONE	---	---
Sand/Dirt	scalar	*Visual	NONE	NONE	---	---
Appearance	scalar	*Visual	NORML	NORML	---	---
Odor	scalar	*Visual	NORML	NORML	---	---
Emulsified Water	scalar	*Visual	>0.2	NEG	---	---
Free Water	scalar	*Visual		NEG	---	---

FLUID PROPERTIES	method	limit/base	current	history1	history2	
Visc @ 40°C	cSt	ASTM D445	222	209	---	---
