OIL ANALYSIS REPORT

Laboratory : WearCheck USA - 501 Madison Ave., Cary, NC 27513
Sample No. : KCPA012465 **Received** : 16 May 2024
Lab Number : 06181990 **Tested** : 20 May 2024
Unique Number : 11033316 **Diagnosed** : 20 May 2024 - Don Baldrige
Test Package : IND 2 (Additional Tests: KF, PrtCount)

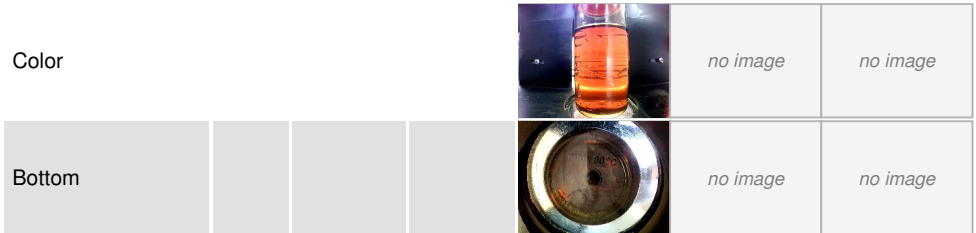
SAMPLE IMAGES	method	limit/base	current	history1	history2
---------------	--------	------------	---------	----------	----------

VISUAL	method	limit/base	current	history1	history2
White Metal	scalar	*Visual	NONE	NONE	---
Yellow Metal	scalar	*Visual	NONE	NONE	---
Precipitate	scalar	*Visual	NONE	NONE	---
Silt	scalar	*Visual	NONE	NONE	---
Debris	scalar	*Visual	NONE	NONE	---
Sand/Dirt	scalar	*Visual	NONE	NONE	---
Appearance	scalar	*Visual	NORML	NORML	---
Odor	scalar	*Visual	NORML	NORML	---
Emulsified Water	scalar	*Visual	>0.05	NEG	---
Free Water	scalar	*Visual		NEG	---
