# OIL ANALYSIS REPORT

**Laboratory** : WearCheck USA - 501 Madison Ave., Cary, NC 27513  
**Sample No.** : WC0923380      **Received** : 17 May 2024  
**Lab Number** : 06183615      **Tested** : 22 May 2024  
**Unique Number** : 11034941      **Diagnosed** : 22 May 2024 - Wes Davis  
**Test Package** : CONST ( Additional Tests: FuelDilution, PercentFuel, TBN )

**MANHATTAN ROAD AND BRIDGE**  
 5601 S 122ND E AVE  
 TULSA, OK 74146  
 Contact: BEN CALDWELL  
 kevin.marson@wearcheck.com  
 T: (918)728-5749  
 F:

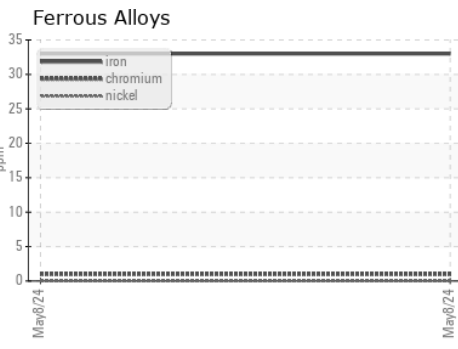
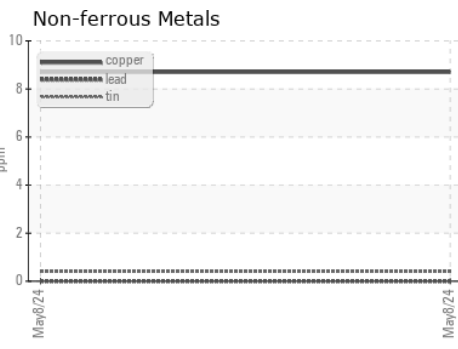
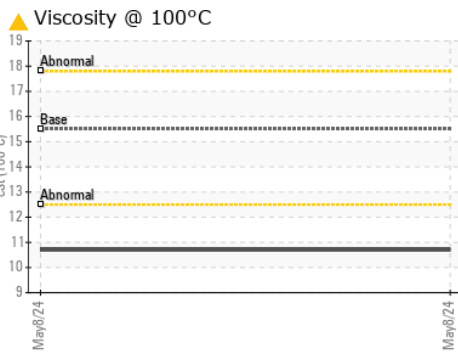
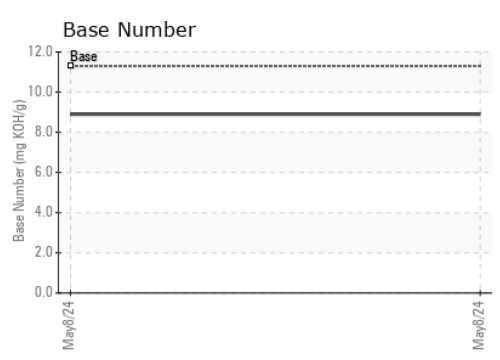
### GRAPHS

FLUID PROPERTIES	method	limit/base	current	history1	history2	
Visc @ 100°C	cSt	ASTM D445	15.5	▲ 10.7	---	---
