OIL ANALYSIS REPORT

Laboratory : WearCheck USA - 501 Madison Ave., Cary, NC 27513
Sample No. : WC0781358
Lab Number : 06195409
Unique Number : 11057532
Test Package : MOB 2
Received : 30 May 2024
Tested : 31 May 2024
Diagnosed : 03 Jun 2024 - Doug Bogart

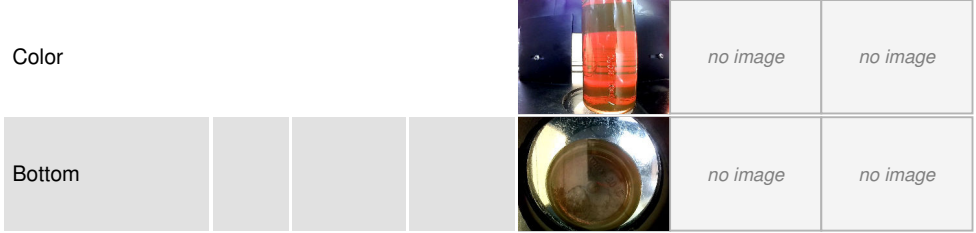
SAMPLE IMAGES	method	limit/base	current	history1	history2
---------------	--------	------------	---------	----------	----------

VISUAL	method	limit/base	current	history1	history2
White Metal	scalar	*Visual	NONE	NONE	---
Yellow Metal	scalar	*Visual	NONE	NONE	---
Precipitate	scalar	*Visual	NONE	NONE	---
Silt	scalar	*Visual	NONE	NONE	---
Debris	scalar	*Visual	NONE	NONE	---
Sand/Dirt	scalar	*Visual	NONE	NONE	---
Appearance	scalar	*Visual	NORML	NORML	---
Odor	scalar	*Visual	NORML	NORML	---
Emulsified Water	scalar	*Visual	>0.1	NEG	---
Free Water	scalar	*Visual		NEG	---
