# OIL ANALYSIS REPORT

**Laboratory** : WearCheck USA - 501 Madison Ave., Cary, NC 27513  
**Sample No.** : KCPA017858 **Received** : 30 May 2024  
**Lab Number** : 06195444 **Tested** : 31 May 2024  
**Unique Number** : 11057567 **Diagnosed** : 31 May 2024 - Angela Borella  
**Test Package** : IND 2 ( Additional Tests: KF, PrtCount )

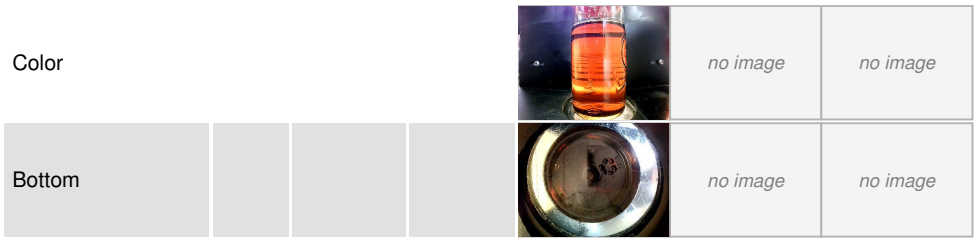
SAMPLE IMAGES	method	limit/base	current	history1	history2
---------------	--------	------------	---------	----------	----------

VISUAL	method	limit/base	current	history1	history2
White Metal	scalar	*Visual	NONE	<b>NONE</b>	---
Yellow Metal	scalar	*Visual	NONE	<b>NONE</b>	---
Precipitate	scalar	*Visual	NONE	<b>NONE</b>	---
Silt	scalar	*Visual	NONE	<b>NONE</b>	---
Debris	scalar	*Visual	NONE	<b>NONE</b>	---
Sand/Dirt	scalar	*Visual	NONE	<b>NONE</b>	---
Appearance	scalar	*Visual	NORML	<b>NORML</b>	---
Odor	scalar	*Visual	NORML	<b>NORML</b>	---
Emulsified Water	scalar	*Visual	>0.05	<b>NEG</b>	---
Free Water	scalar	*Visual		<b>NEG</b>	---
