OIL ANALYSIS REPORT

Laboratory : WearCheck USA - 501 Madison Ave., Cary, NC 27513
Sample No. : WC0930103 **Received** : 30 May 2024
Lab Number : **06195940** **Tested** : 14 Jun 2024
Unique Number : 11058063 **Diagnosed** : 14 Jun 2024 - Doug Bogart
Test Package : AOM 1 (Additional Tests: KF)

SRP - Salt River Project
 SRP Mail Station POB003, P.O. Box 52025
 Phoenix, AZ
 US 85072-2025
 Contact: Chris Keisling
 chris.keisling@srpnet.com

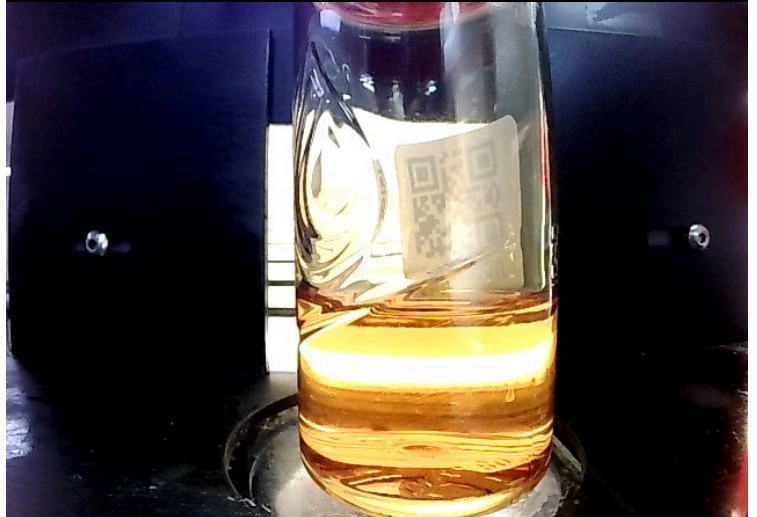
Sample Color & Clarity

| VISUAL | method | limit/base | current | history1 | history2 |
|---|---|---|---|---|---|
| Appearance | scalar | *Visual | NORML | NORML | --- |
