OIL ANALYSIS REPORT

Machine Id
SCREEN 5

Component
Rear Gearbox

Fluid
JAX SYNGEAR INDUSTRIAL GEAR ISO 220 (--- GAL)

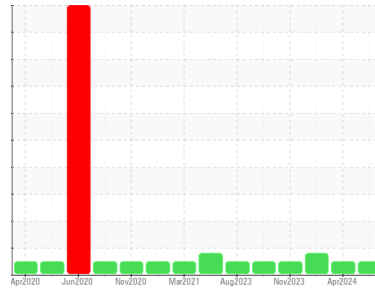
Sample Rating Trend

NORMAL

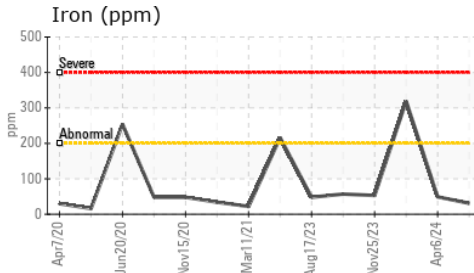
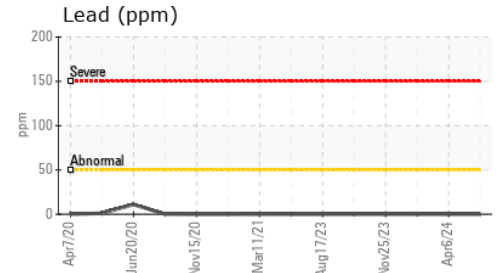
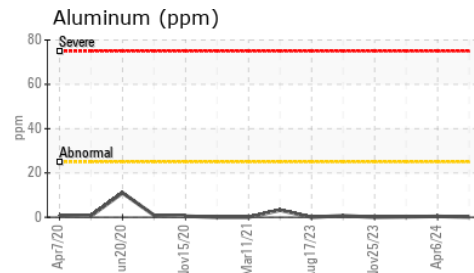
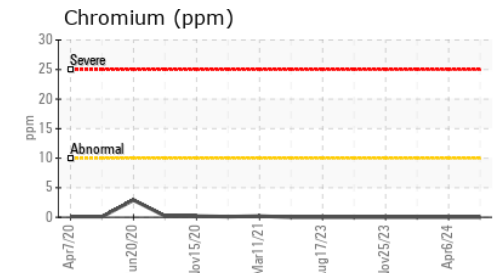
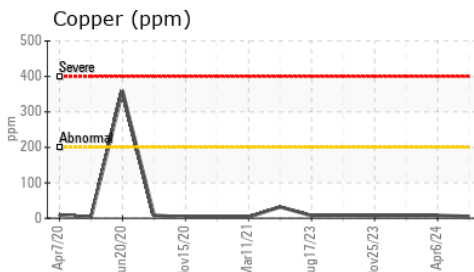
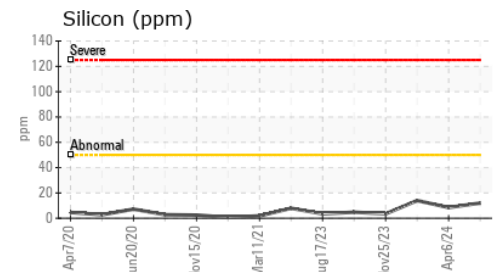
GRAPHS

All component wear rates are normal.

There is no indication of any contamination in the oil.

The condition of the oil is acceptable for the time in service.

Resample at the next service interval to monitor. Please specify the component make and model with your next sample.
