OIL ANALYSIS REPORT

Laboratory : WearCheck USA - 501 Madison Ave., Cary, NC 27513
Sample No. : KC122944
Lab Number : **06202701**
Unique Number : 11070162
Test Package : IND 2
Received : 07 Jun 2024
Tested : 10 Jun 2024
Diagnosed : 10 Jun 2024 - Don Baldrige

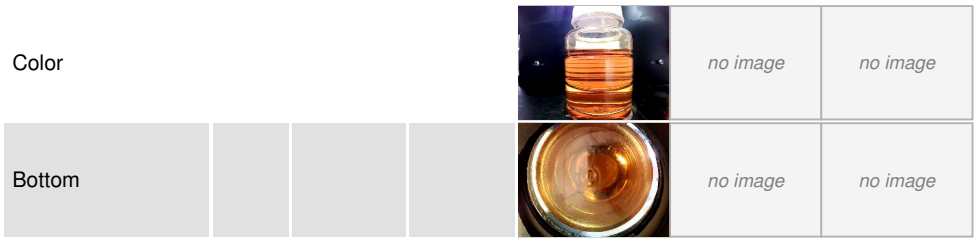
SAMPLE IMAGES	method	limit/base	current	history1	history2
---------------	--------	------------	---------	----------	----------

VISUAL	method	limit/base	current	history1	history2
White Metal	scalar	*Visual	NONE	NONE	---
Yellow Metal	scalar	*Visual	NONE	NONE	---
Precipitate	scalar	*Visual	NONE	NONE	---
Silt	scalar	*Visual	NONE	NONE	---
Debris	scalar	*Visual	NONE	LIGHT	---
Sand/Dirt	scalar	*Visual	NONE	NONE	---
Appearance	scalar	*Visual	NORML	NORML	---
Odor	scalar	*Visual	NORML	NORML	---
Emulsified Water	scalar	*Visual	>0.05	NEG	---
Free Water	scalar	*Visual		NEG	---
